Horatia House and Leamington House

Cladding Removal

Progress Report 9th October 2017

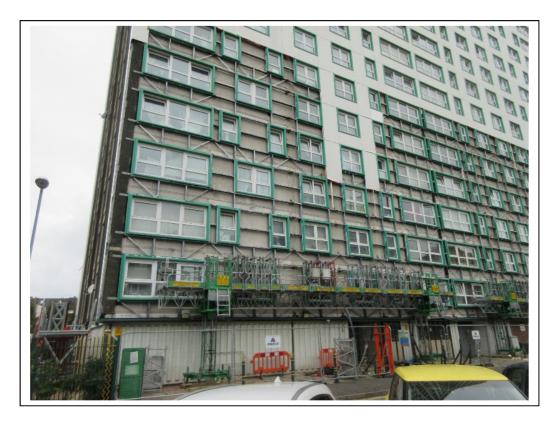
Figure 1 - East Elevation cladding removed to 6th floor, mast climber installed to 1st floor level

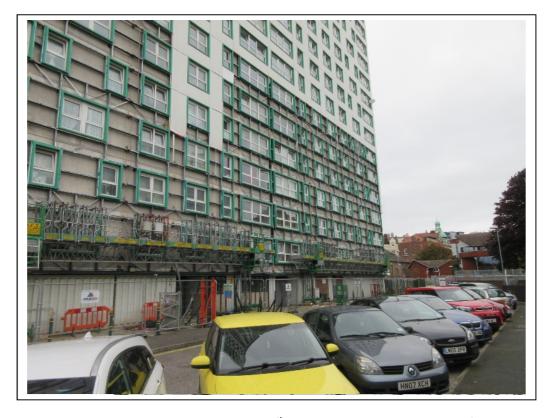
Figure 2 - East Elevation cladding removed to 6th floor, mast climber installed to 1st floor level

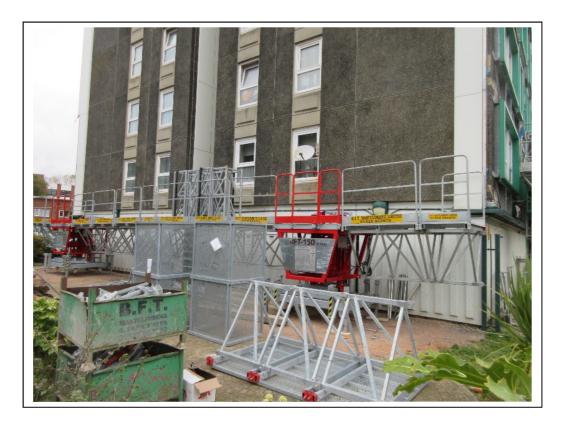
Figure 3 - Mast climber being installed to south elevation

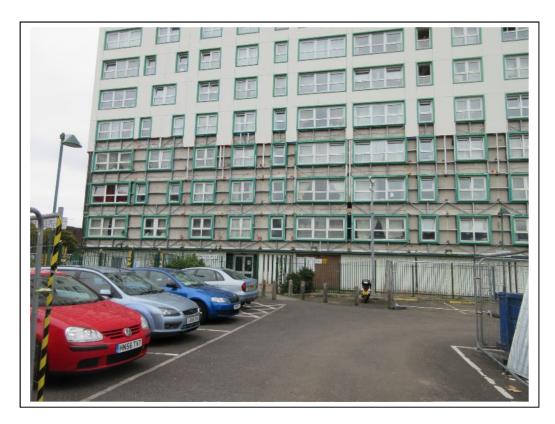
Figure 5 - West elevation, cladding removed to the $\textbf{4}^{\text{th}}$ storey

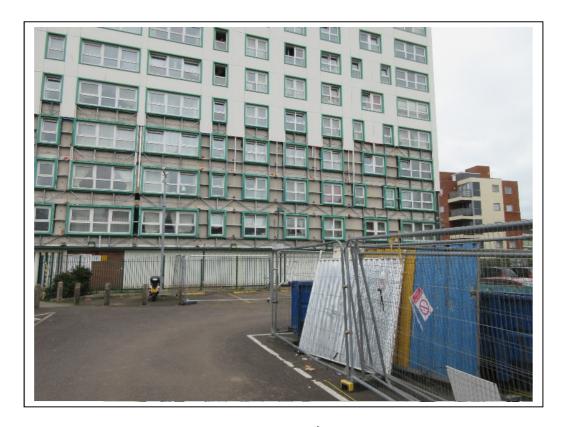
Figure 6 - West elevation, cladding removed to the $\mathbf{4}^{\text{th}}$ storey

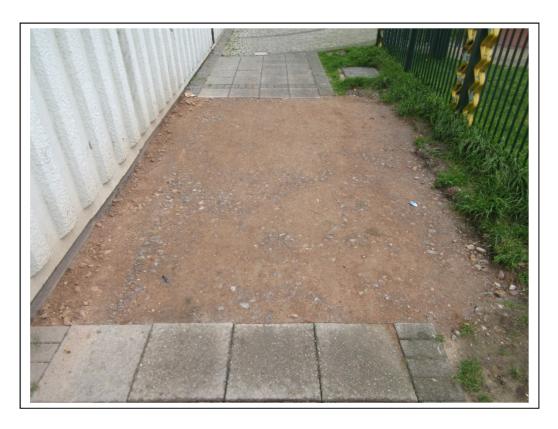
Figure 7- Example of a completed foundation to enable the mast climber installation

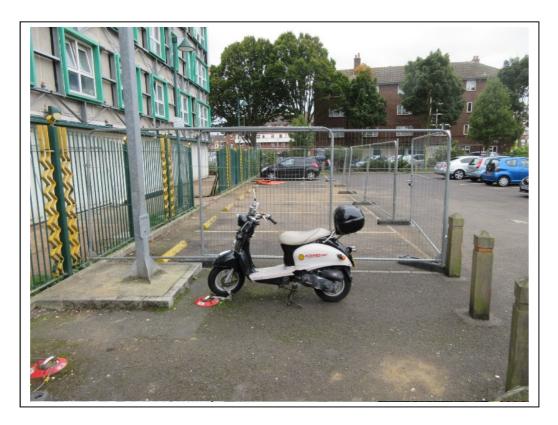
Figure 8 - Restricted car parking in car park to west of block

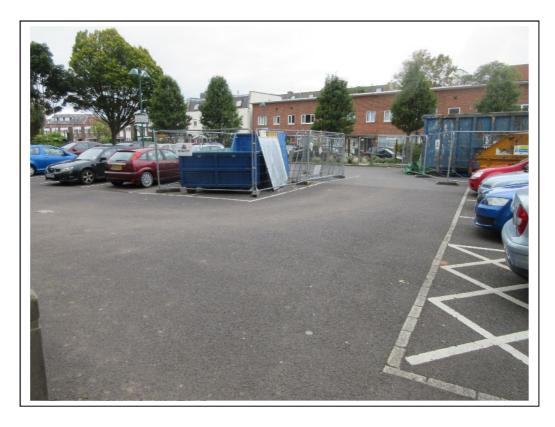
Figure 9- Use of carpark to west of building for contractor storage

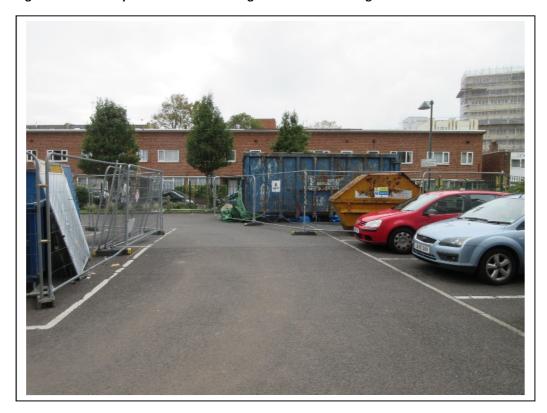
Figure 10 - Use of carpark to west of building for contractor storage

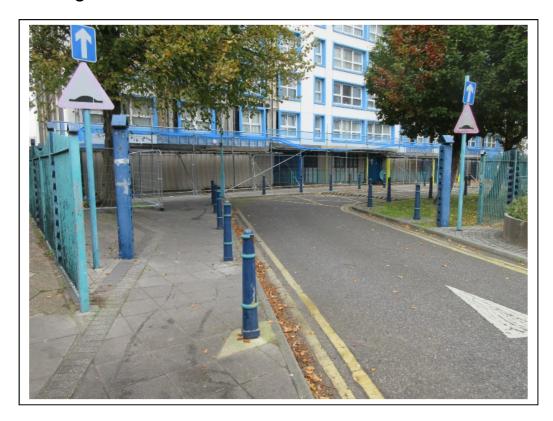
Figure 11 - Scaffold fan erected to main entrance, east elevation

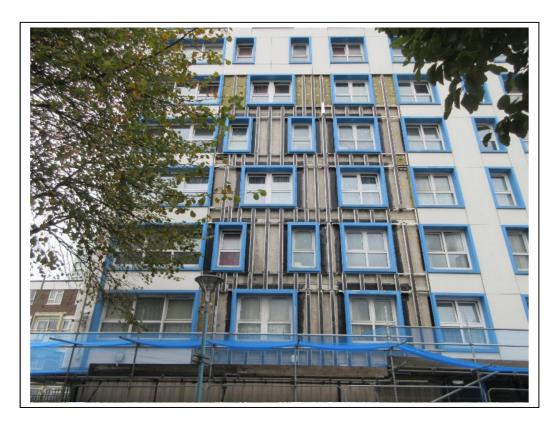
Figure 12 - East elevation, cladding partially removed to the 5th floor

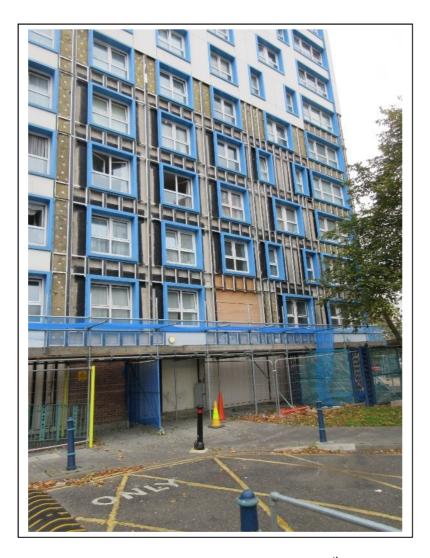
Figure 13 - East elevation cladding partially removed to 5th floor

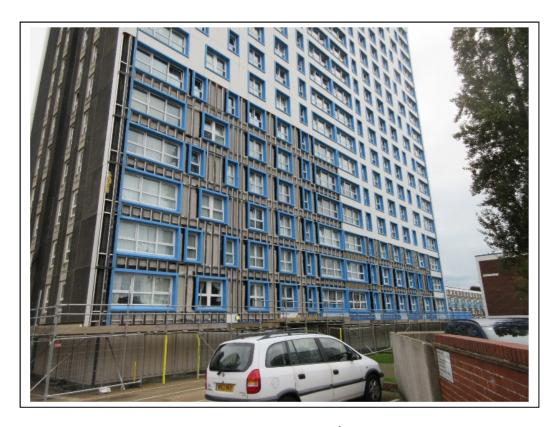
Figure 14 - West elevation, 50% of cladding removed to 7^{th} storey, remainder of cladding removed to 4^{th} storey

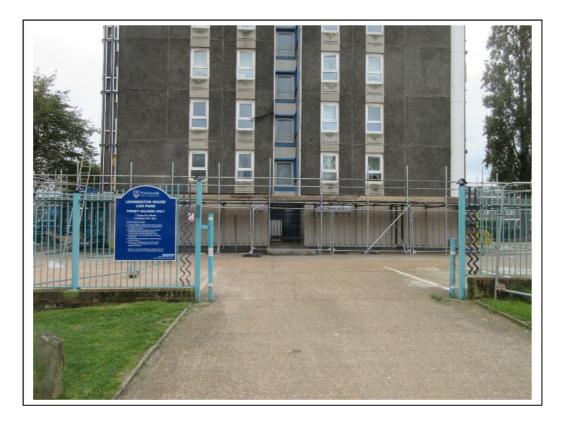
Figure 15- Scaffold fan install to north elevation

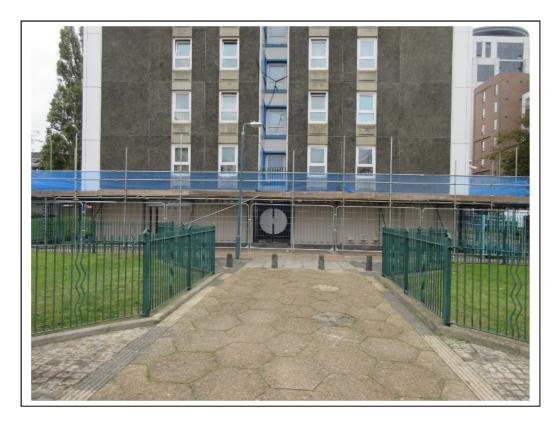
Figure 16 - Scaffold fan installed to south elevation
