Decision maker: Cabinet Member for Housing

Subject: EASTERN ROAD AND ASSOCIATED WORKS 2012

Date of decision: 8th November 2011

Report by: OWEN BUCKWELL – HEAD OF HOUSING
MANAGEMENT

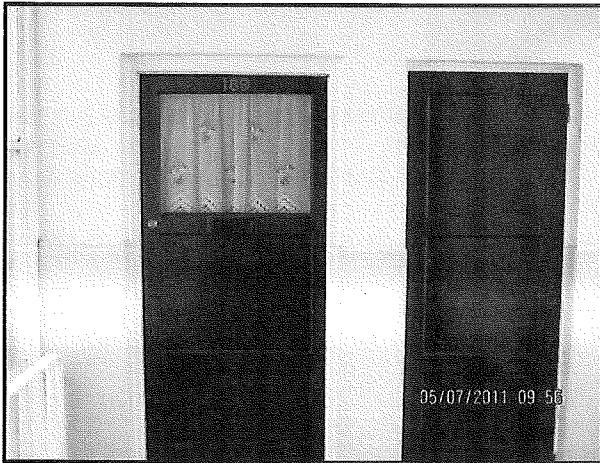
Leaving the existing property doors in place and upgrading them was rejected in favour of replacing them with composite fire doors. A large number of the existing wooden doors are not suitable to be upgraded so would therefore require replacement with new timber doors, this would negate some of the initial cost savings associated with timber vs composite doors. There is also the issue of ongoing maintenance, with timber doors requiring periodic decoration which will be eliminated using composite doors.

Figure 1 Original timber panelled non fire doors require replacement

Property front doors and associated store doors are to be replaced with fire resistant composite doors to provide a safer escape route. The fire resistant front doors will form a compartment to contain any outbreak of fire within a property and also allow other tenants the ability to make their escape. Additionally the provision of emergency lighting to aid emergency escape is to be installed.

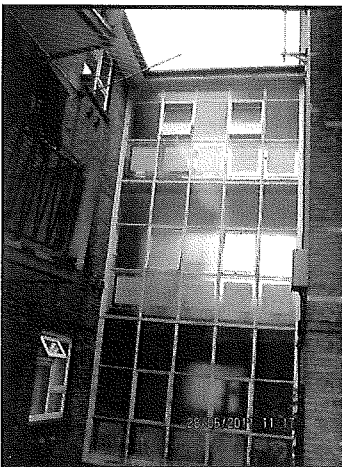
The glazed screens are original and have reached the end of their serviceable life, therefore would require large amount of ongoing repair in order to maintain their appearance and integrity. There is also a need to provide fire resistance to part of the glazed screens.

Figure 2 Existing glazed screens South elevation

- 2.2 The proposed works to the Eastern Road blocks consist of replacing glazed screens to the communal stairwells as there is a requirement for the screens to afford fire protection to the stairwell in order to prevent the spread of fire from the stairwell to adjacent flats within the block and visa versa. The screens are in poor decorative order and are glazed with materials that do not conform to current Building Regulations.

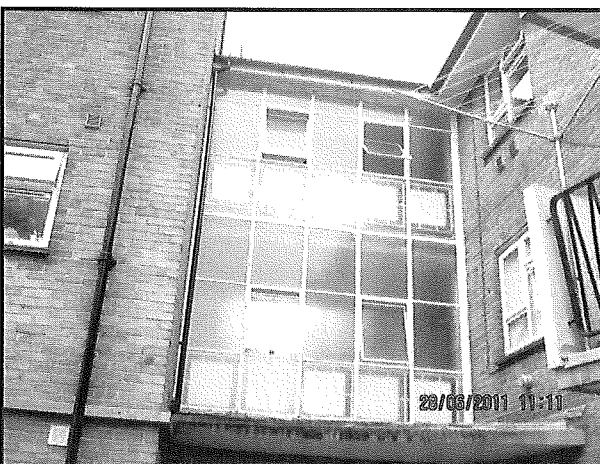
Figure 3 Existing glazed screens South elevation
