Title of meeting: The Leader with responsibility for Planning, Regeneration and Economic Development

Subject: Portsmouth International Port:
Members duties as the Duty Holders for the Port under the Updated Port Marine Safety Code, Port Marine Safety Code Audit, Harbour Incidents, and Traffic Throughput

Date of meeting: 21 November 2017

Report by: Port Director

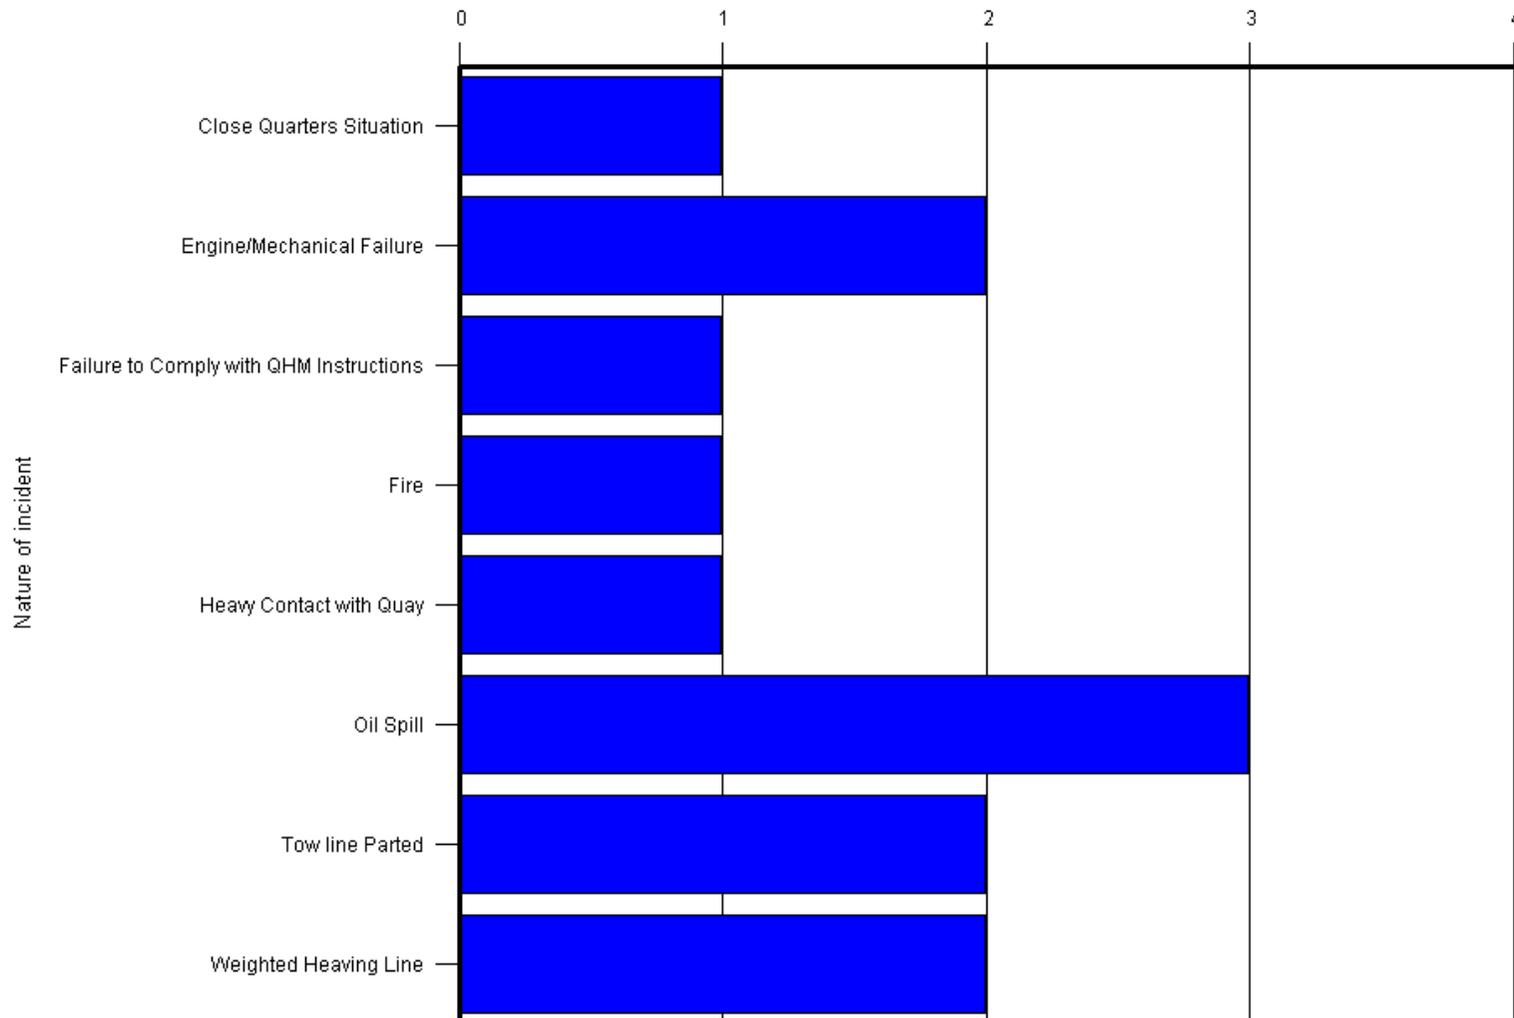
Reported Incidents - 1 January to 30 September 2017

The total number of reported incidents from 01 January 2017 to 30 September 2017 was 13.
