atlantic crest

Appendix 2

Risk Management of Coastal Water Sites

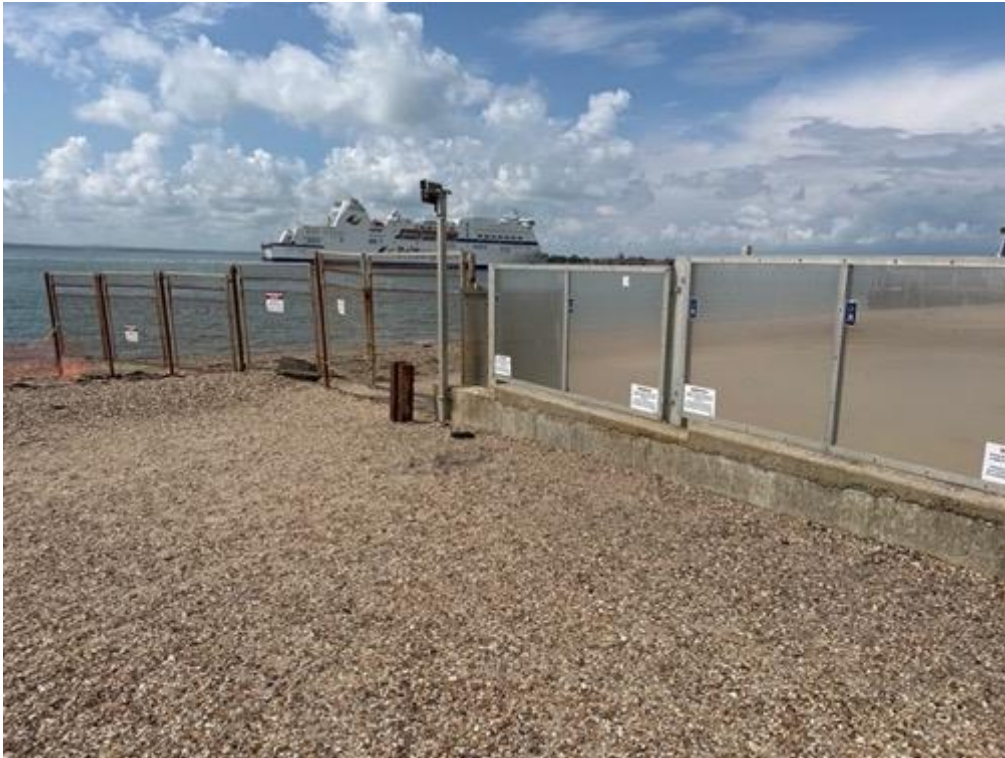
Photograph Z.2.a.1: Hoverport with Edge Protection and Warning Signs

The beach and tides are natural processes. There are no hidden hazards. The Hoverport has edge protection, see below, Photographic Plate Z.2a.1.

The First sign is by the Hoverport and close to the high level of beach activity/traffic feeder point from fair/F&B. There are also danger warning signs on the Hoverport barriers, Photographic Plate Z.2a.1. Identical signage each side of rowing club - consider effectiveness, remove both or one during SF3 works, Photographic Plate Z.2a.4 and Photographic Plate Z.2a.5.

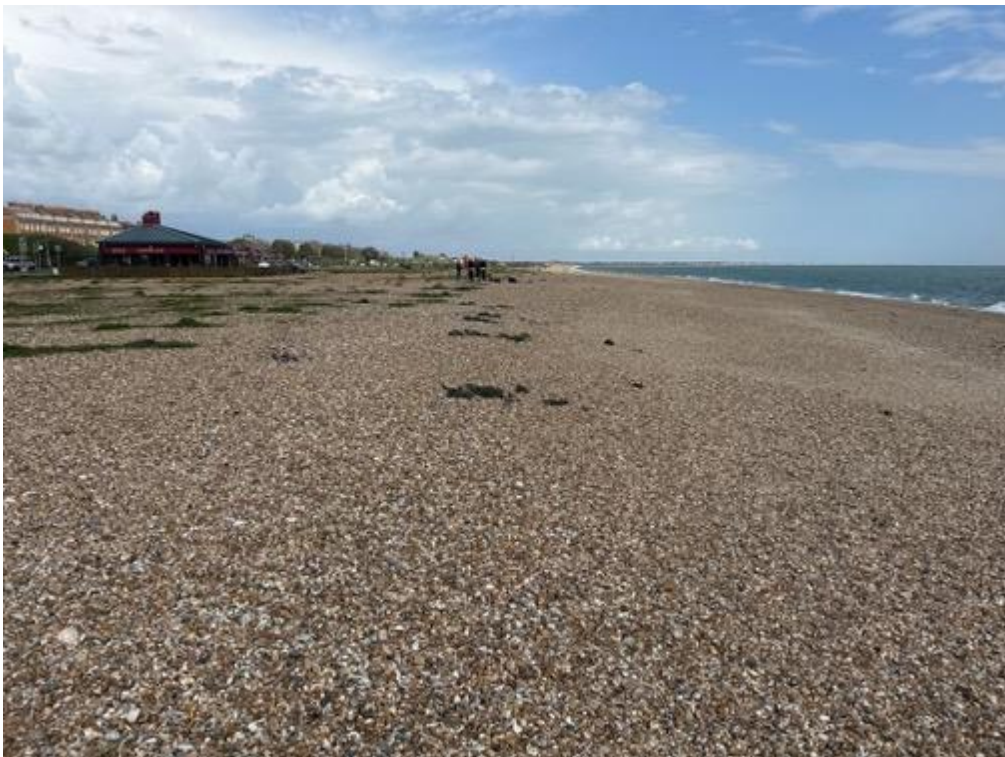
Photograph Z.3.1: Coffee Cup and PRE

The area starts with Coffee Cup which creates a central point and there is a PRE life ring adjacent, Photographic Plate Z.3.1. There are beach huts along this stretch. Dog walking during the summer is restricted west of Coffee Cup.

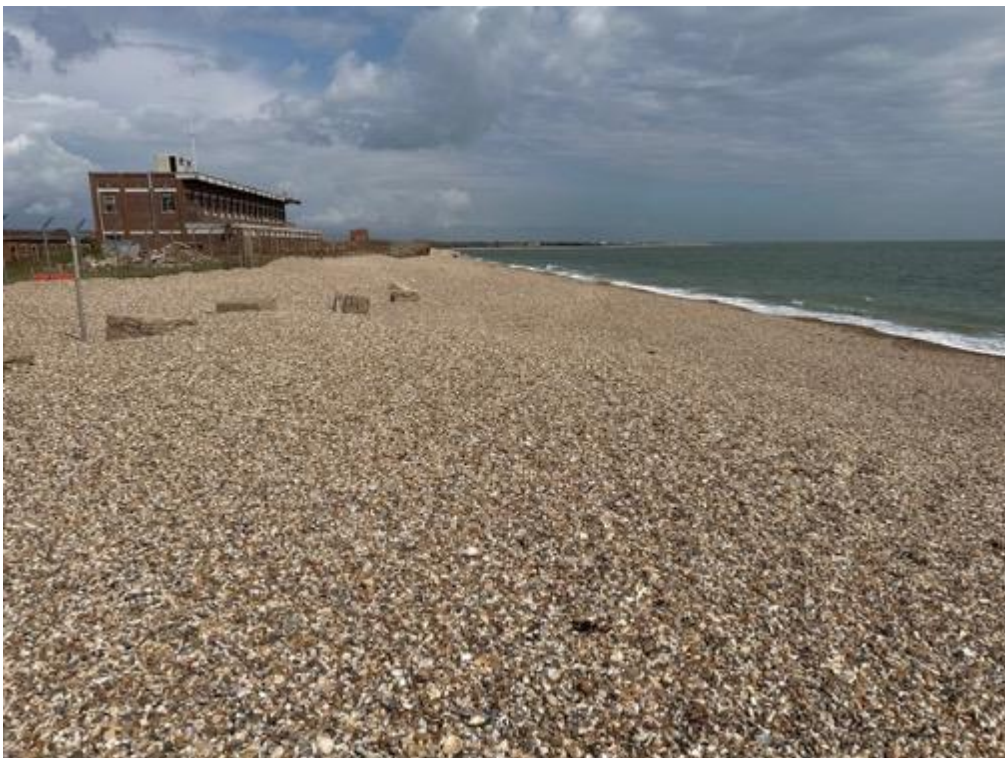
Photographic Plate Z.3.3: Naturist Beach

There is a naturist beach at eastern-most end, Photographic Plate Z.3.3.

Nothing at naturist beach/path cut through.

Place ring where path joins beach as swimming activity by naturists.

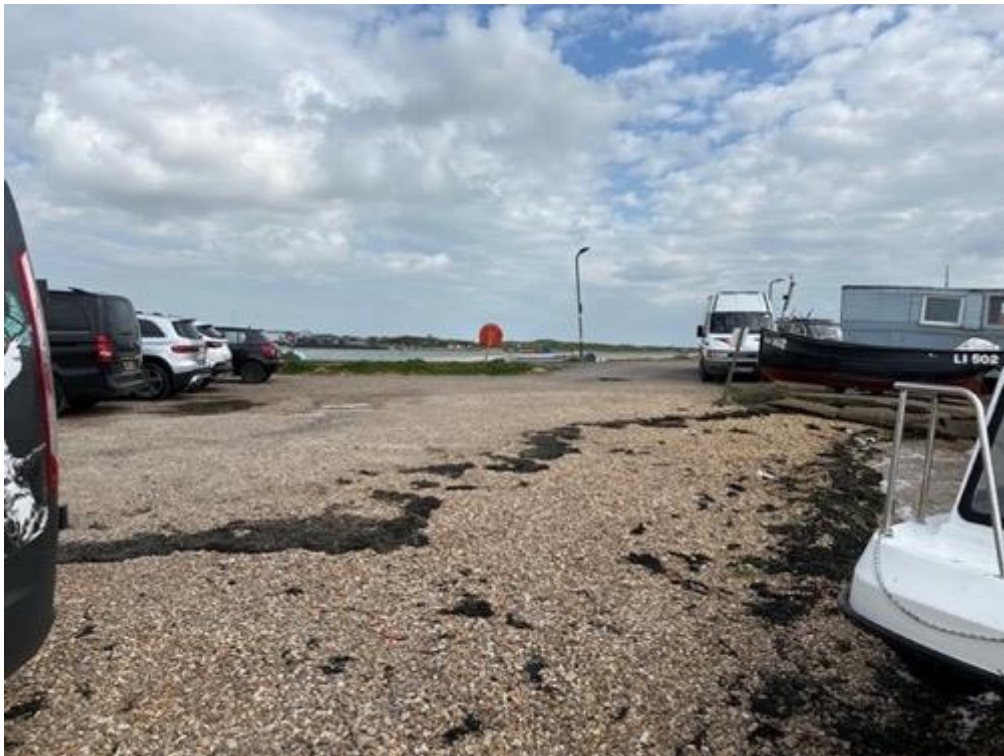
Photograph Z.4.1 PRE on top of Beach at Car Park

A very strong tide runs along this stretch and combined with steep gradient of beach, creating a drowning risk. There are a number of PRE appliances, e.g Photographic Plate Z.4.1.

There are a number of PRE appliances, including the one shown in Photographic Plate Z.4.1.

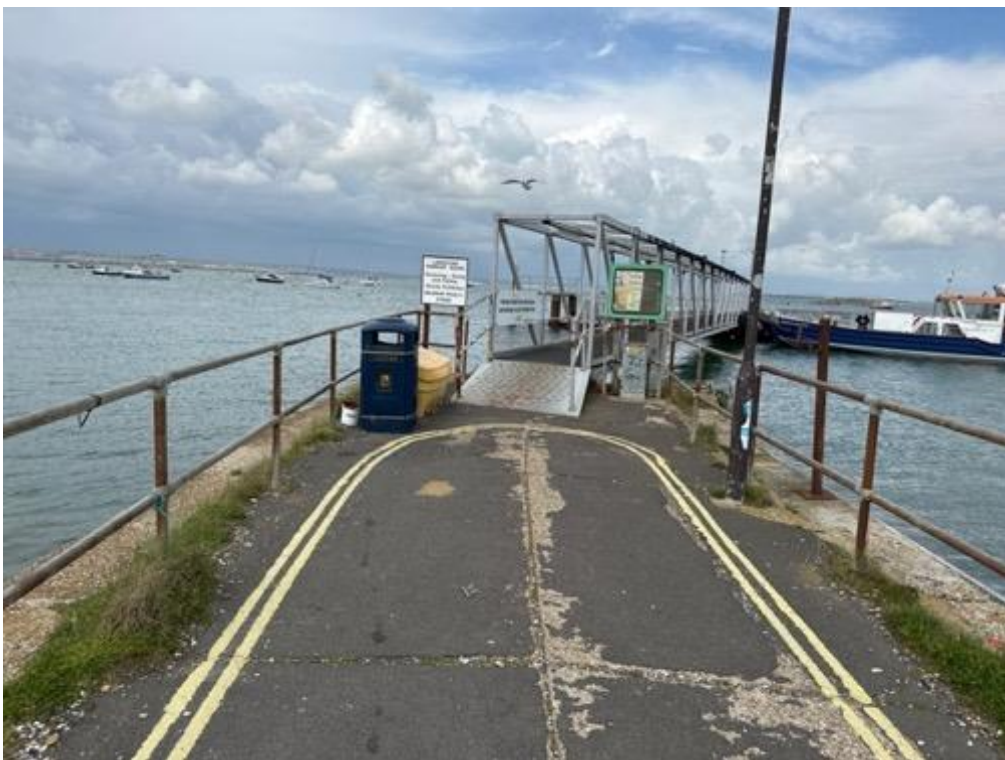
Photograph Z.4.3. Slipway Managed by Langstone Harbour Board

The slipway is not the responsibility of PCC, Photographic Plate Z.4.3.

This is not the responsibility of PCC but there are railings in place on the slipway and a prohibition no access sign. The edge of the water way opposite the slipway is shallow with no obvious hazards.
