atlantic crest

Appendix 2

Risk Management of Coastal Water Sites

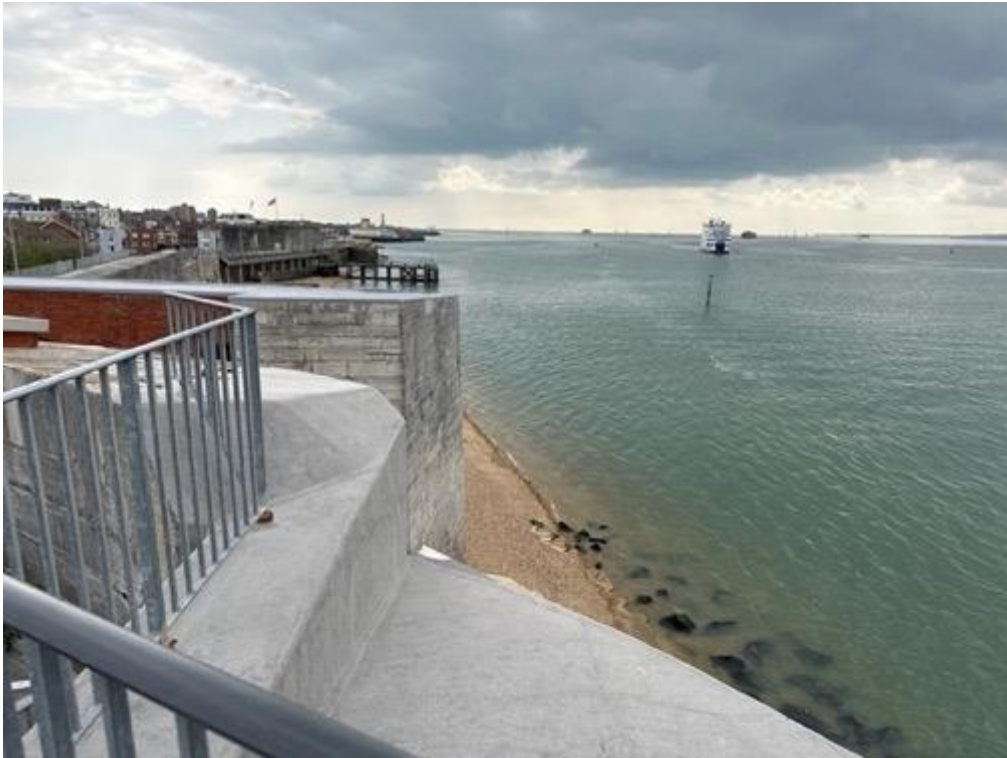
Photograph Z1.1: View from Round Tower

There is a youth culture and associated anti-social behaviour in this area. The Round Tower, Photograph Plate Z1.1, is used by youths for jumping into the sea. There is signage prohibiting jumping from tower, Photograph Plate Z1.2.

At the Round Tower there are railings that create a barrier from people falling into the water, Photographic Plate Z.1.1.

The signage for the Round Tower and jumping risk is adequate with appropriate edge protection. No additional signage is required for the upper deck of the Round Tower.

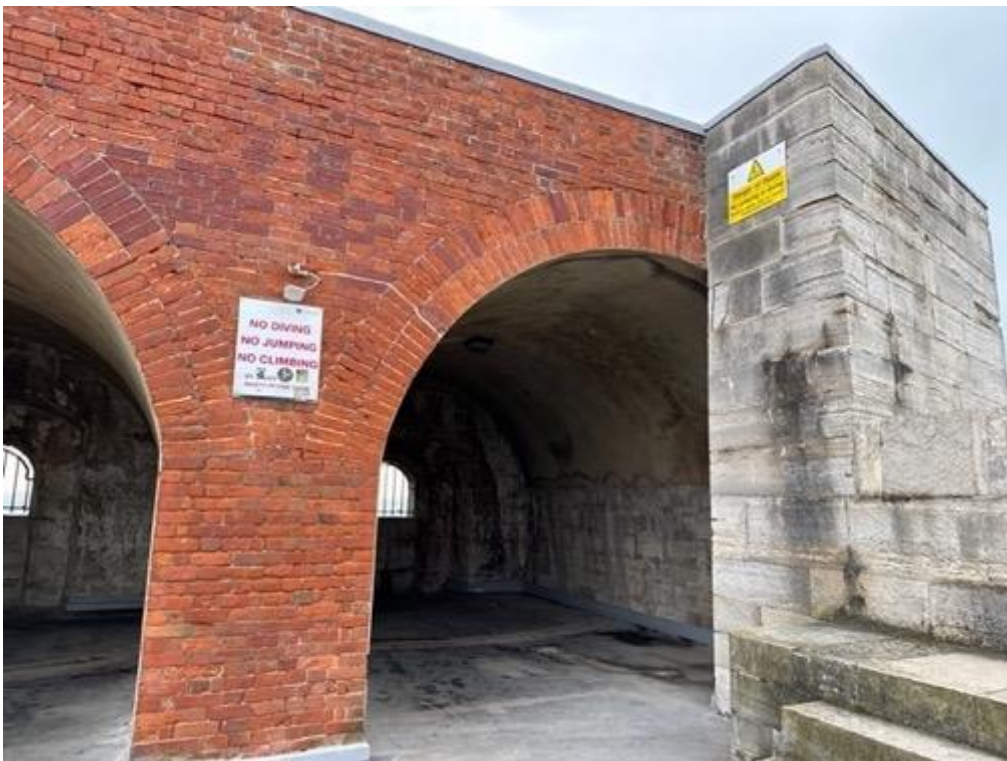
Photograph Z1.2: Signage Leading to Tower

There are two signs on the entrance to the Round Tower, Photographic Plate Z1.2., prohibiting climbing, jumping and diving in addition to a danger warning of death from jumping and diving. There also 2 signs on upper level by Round Tower stairs including 'don't jump' and you will be fined for doing so. There are no signs on top of the Round Tower.

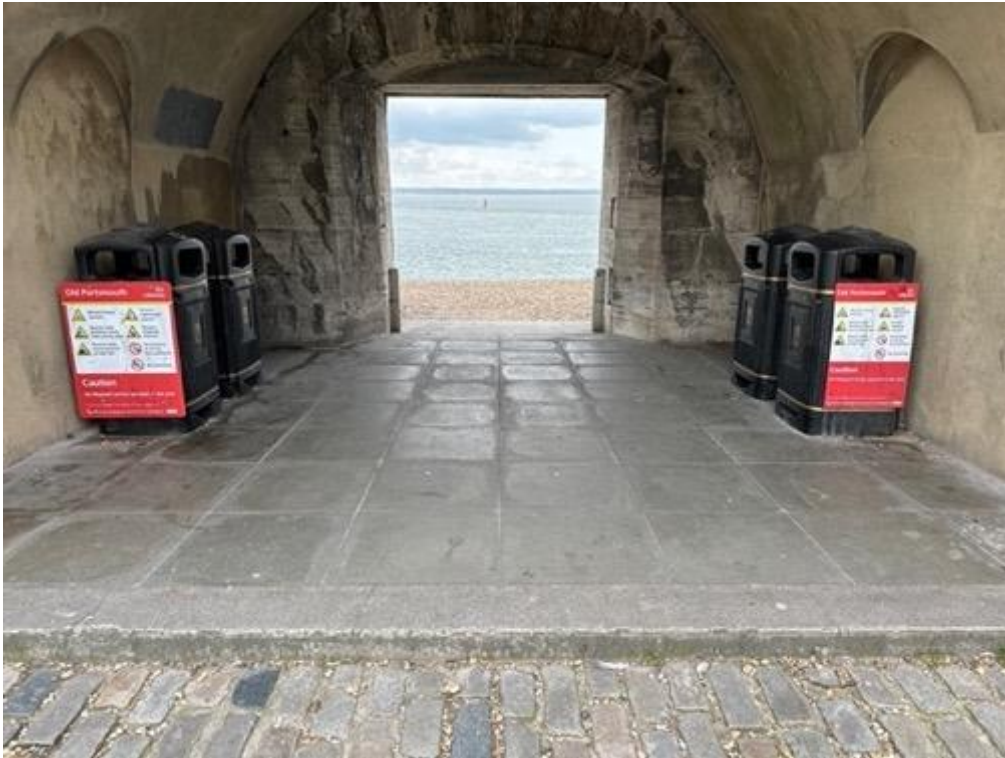
Photograph Z1.3: Entrance to Hotwalls with RNLi Signage

Local residents are passionate sea swimmers off Hot Walls Beach. This not a recognised swimming area due to the tides and there is signage to note this at the entrance top Hot Walls beach, Photographic Plate Z1.3. A section of the local sea swimmers have knowledge of the tides.

There are two signs to the entrance to Hot Walls, Photographic Plate Z1.2, highlighting the hazards and clearly stating this is not a swimming beach and not lifeguarded. RNLI signage at PRE points + no jumping sign at V shaped path.

There is adequate RNLI signage at the entrance to Hot Walls. There is a PRE device near the Round Tower which is in the correct location. The line is too short and needs to be replaced.

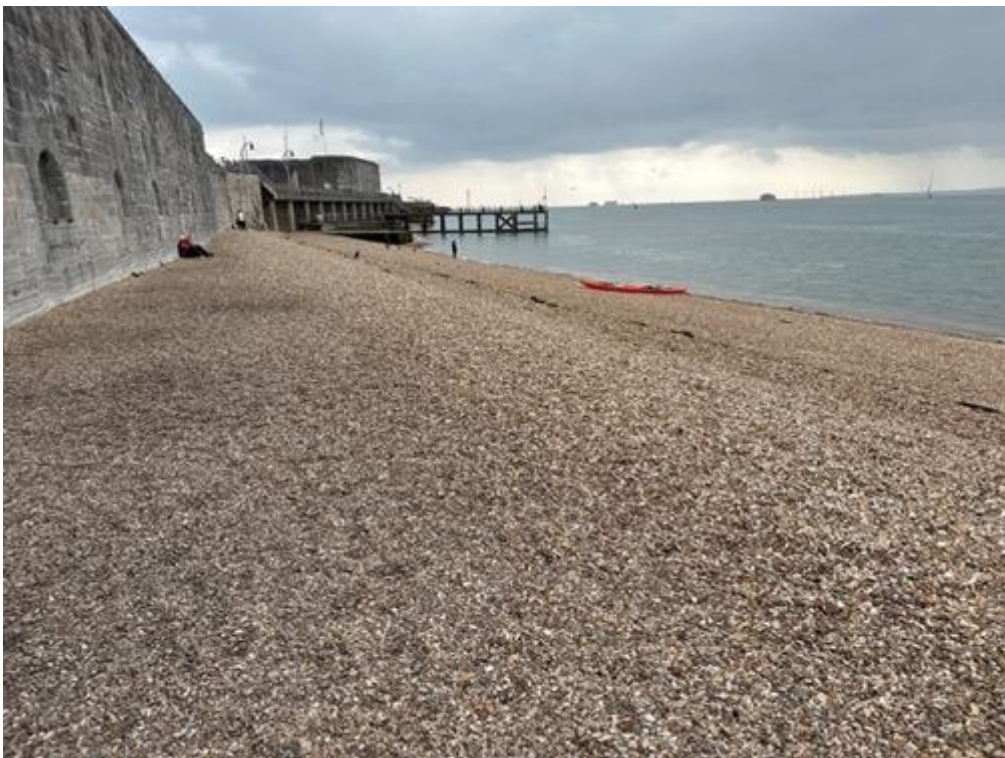
Photograph Z1.4: Hot Walls Beach

Hot walls is not a swimming beach with very strong currents into and out of the harbour entrance, Photographic Plate Z.1. 4. People do swim here, particularly locals, and people have drowned at this beach.

The pier is used for jumping which creates a risk and is dangerous for weak swimmers or when the tide is out, Photographic Plate Z.1.4.

Second PRE needs to be located close to the pier and a sign on the pier to say no jumping or diving.

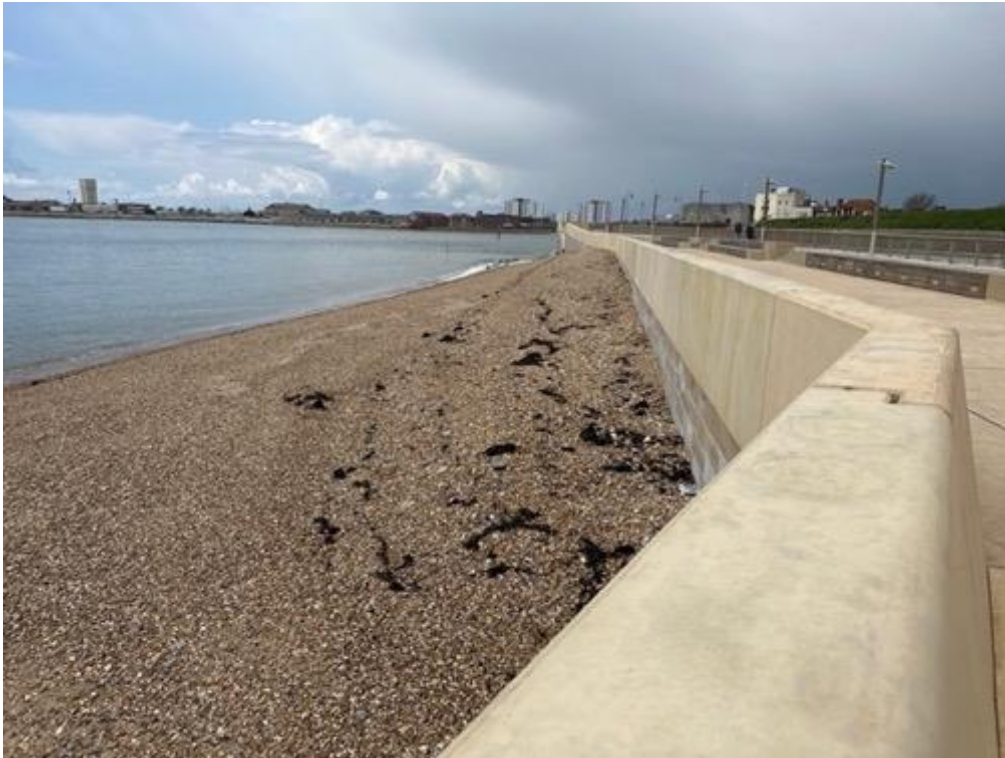
Photograph Z1.5: Sub-Frontage Beach and Sea Wall

The beach on the seaward side of the wall is not for access and can create a cut-off for people access the beach, Photographic Plate Z.1.5.

The Long Curtain promenade has a new engineered sea wall and flood gates Z.1.5.

There is strong engineered edge protection and PRE at each flood gate. There needs to be sign on each gate stating no access and tidal cut-off. Beneath this signage include 'risk of tidal cut-off'. There is a symbol for tidal cut-off. Consider whether there is a need for a sign regarding jumping at the V-shaped section.

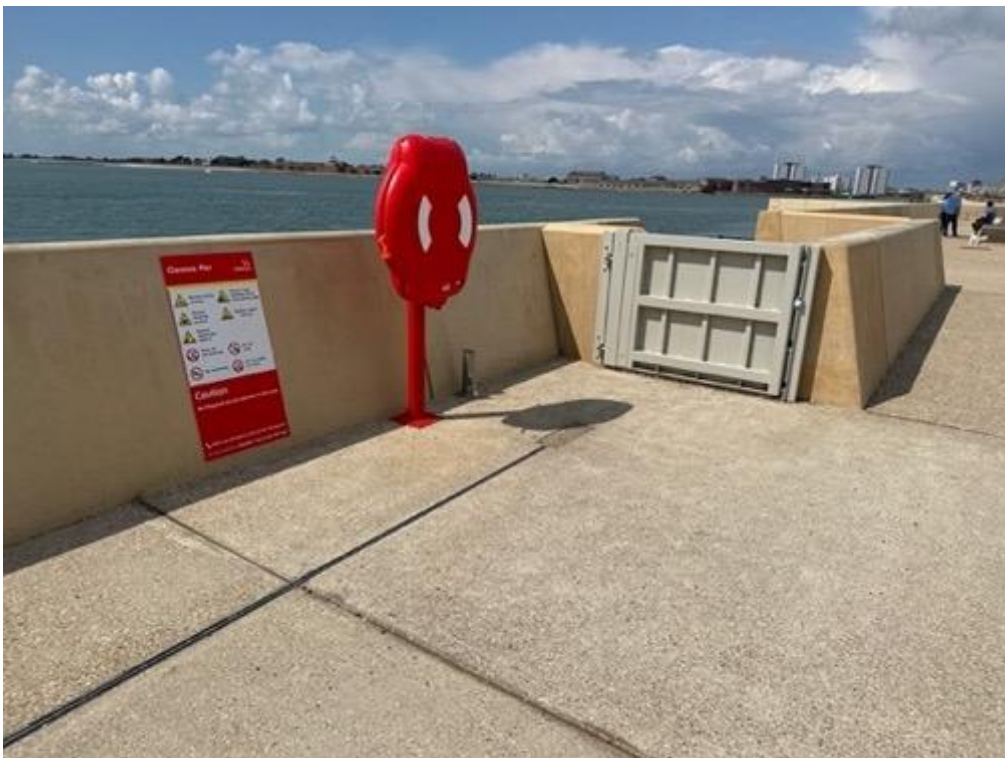
Photograph Z1.6: Sub-Frontage Flood Gate

- 1x lifering on beach closest to Round Tower - rope length inadequate
- 1x lifering by Sally Port gate - enclosed ring holder and re-locate to Victoria Pier
- 2x liferings on SF1 by flood gate stairwells, Photographic Plate Z.1.6

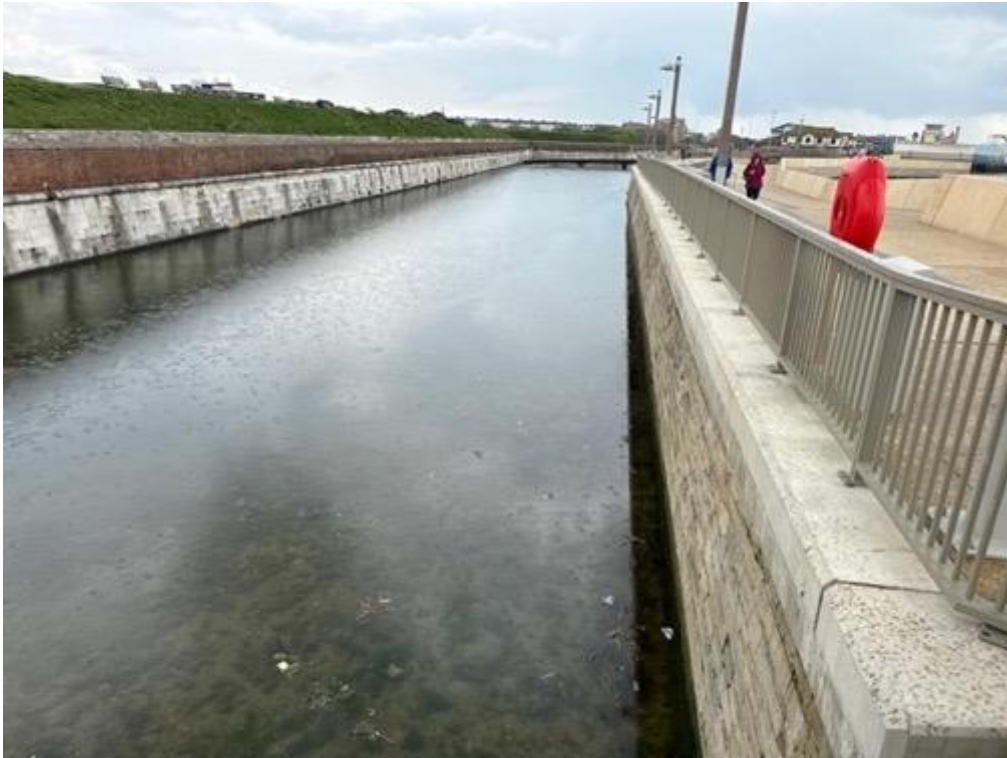
Photograph Z1.7: Moat

The moat is not used for swimming and is visibly shallow, Photographic Plate Z1.7.

The moat does not present a major issue as it is not used for any water activity and not inviting but also is shallow. For any particular incident there are PRE located on the Sub-frontage sea wall.

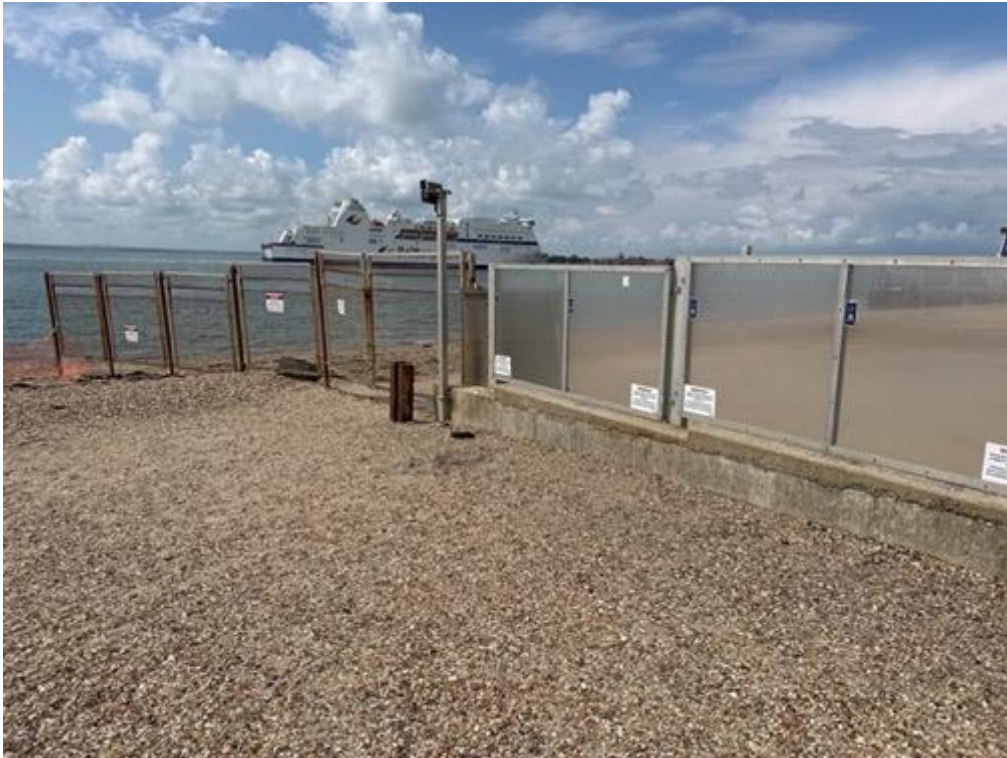
Photograph Z.2.a.1: Hoverport with Edge Protection and Warning Signs

The hovercraft docks at the Hoverport zone and ferries to and from the Isle of Wight through the day and is popular with out of town tourists, Photographic Plate 2a.1. The beach is used for sunbathing and paddling in the summer but is not safe for swimming and is not a designated swim zone, Photographic Plate 2a.2.

The beach and tides are natural processes. There are no hidden hazards. The Hoverport has edge protection, see below, Photographic Plate Z.2a.1.

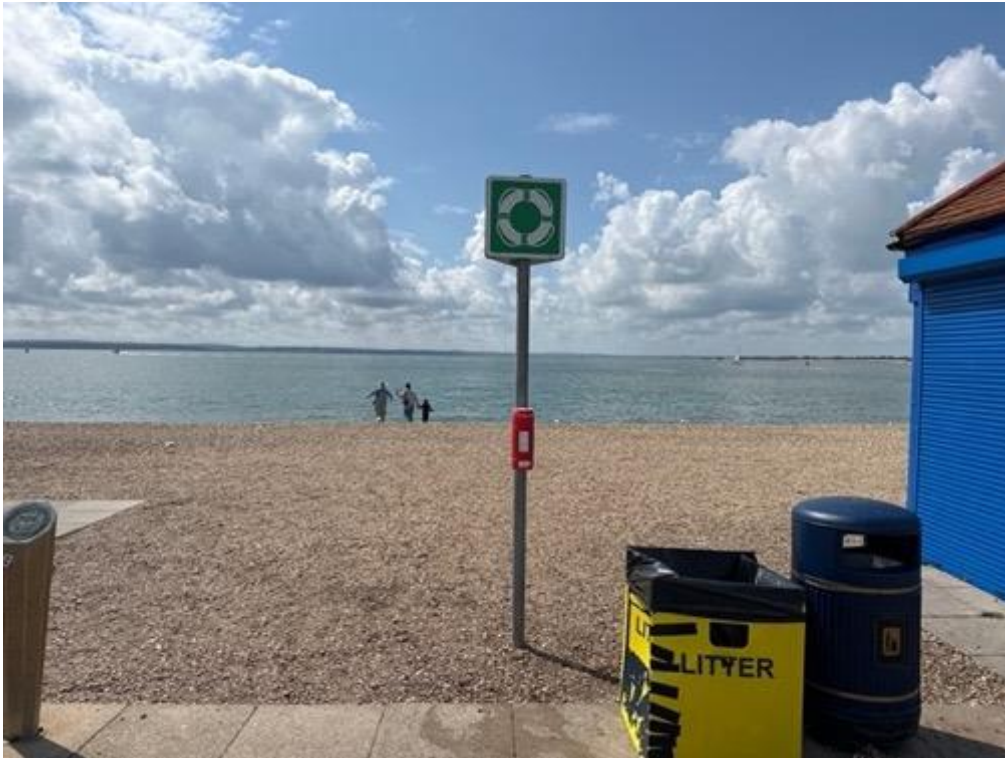
Photographic Plate Z.2a.3.: Rescue Line

There is a mix of life rings and rescue lines along this stretch, like Photographic Plate Z.2a.3 by Hoverport. Trials of using the rescue line were not effective and the green sign with the rescue line was not obvious. In line with the RNLI guidance on public rescue equipment and to create a consistent approach all PRE will be life rings.

Change rescue lines to life rings for consistency. Remove one signage post next to the rowing club.

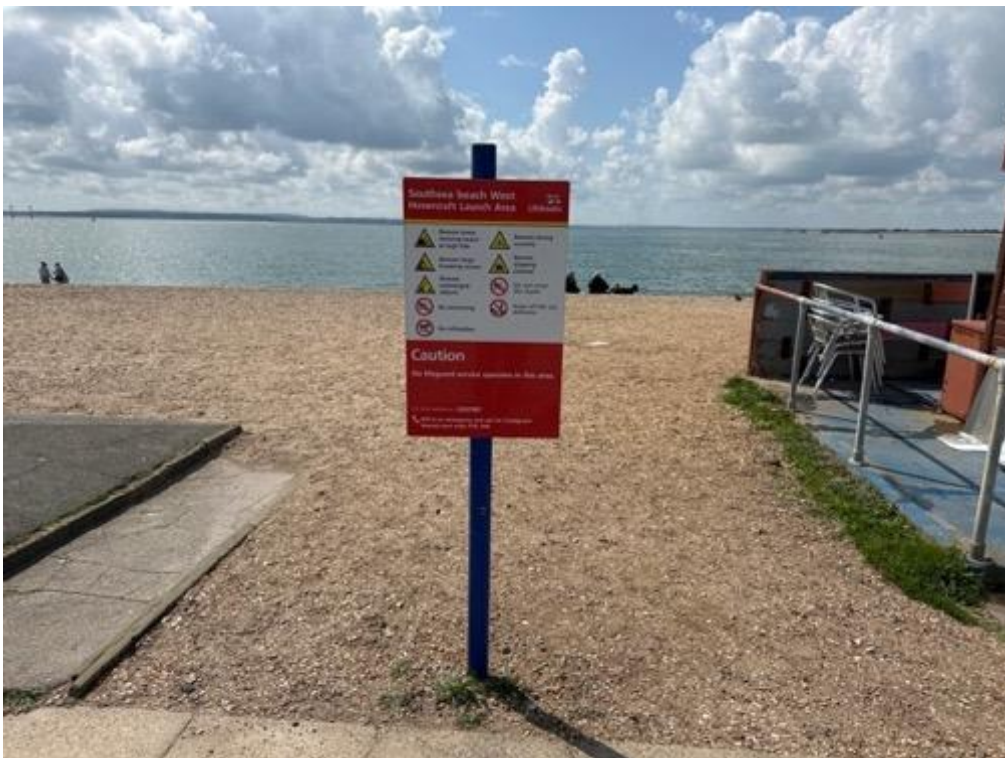
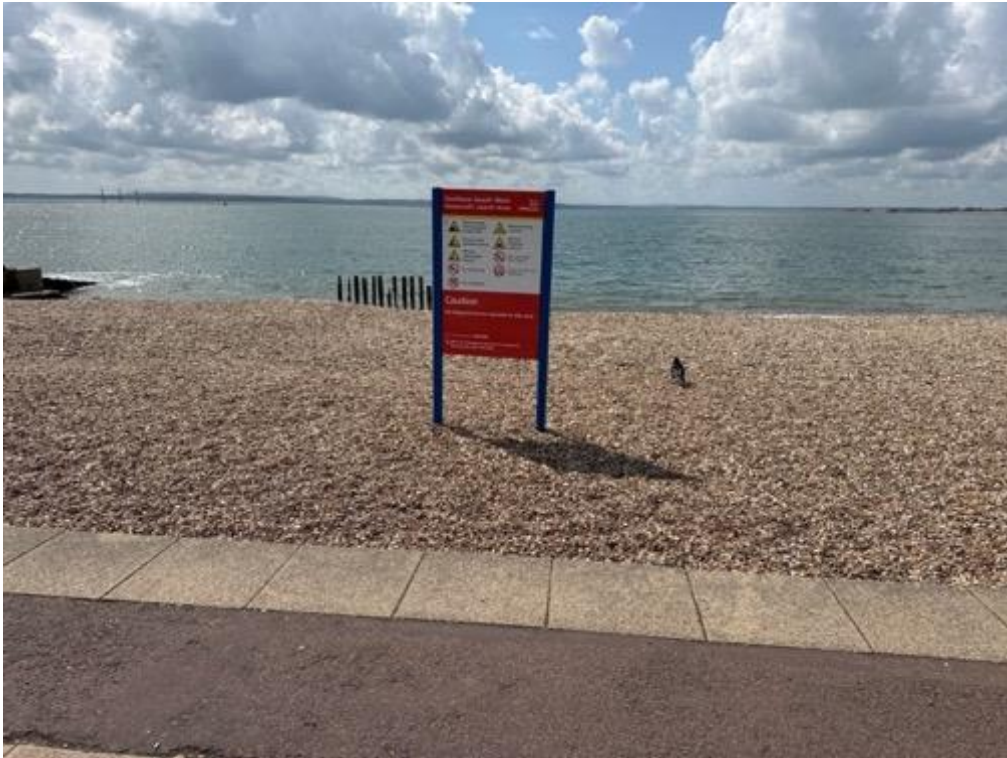
The First sign is by the Hoverport and close to the high level of beach activity/traffic feeder point from fair/F&B. There are also danger warning signs on the Hoverport barriers, Photographic Plate Z.2a.1. Identical signage each side of rowing club - consider effectiveness, remove both or one during SF3 works, Photographic Plate Z.2a.4 and Photographic Plate Z.2a.5.

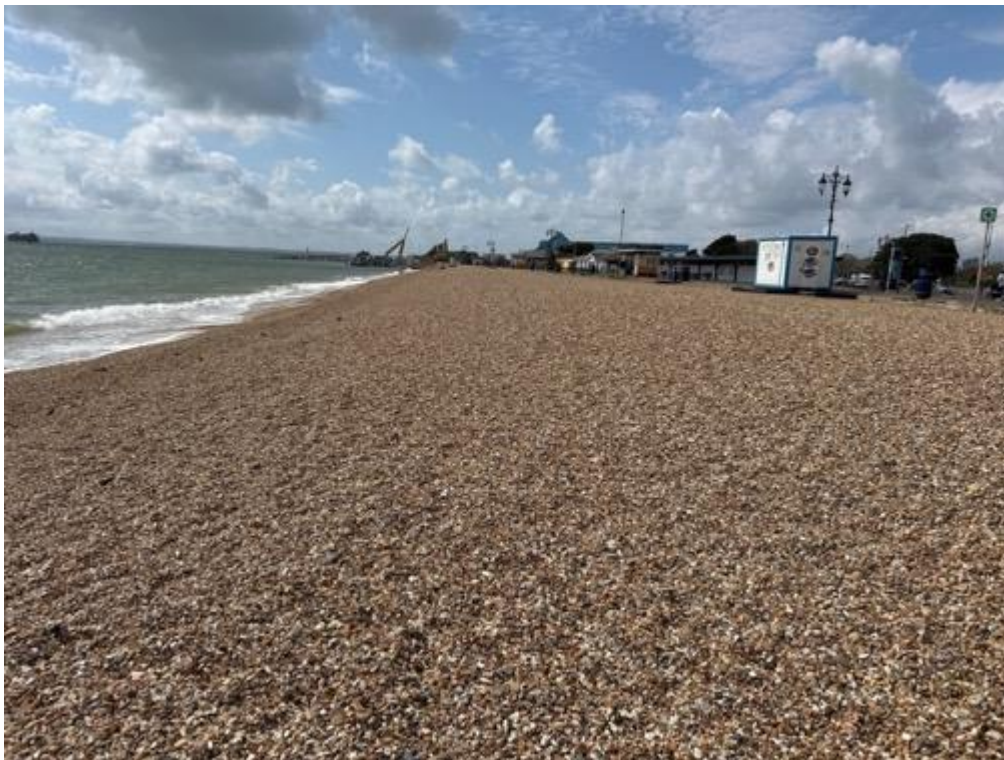
Photograph Z.2b.1 : Beach Showing Lifeguard Hut and Rescue Line

This is a sandy plateau at low spring tide. Attractive for families due to presence of sand on historically shingle beach, Photograph Plate Z.2b.1.

Change throwlines to life rings for ease of use, efficacy and consistency.

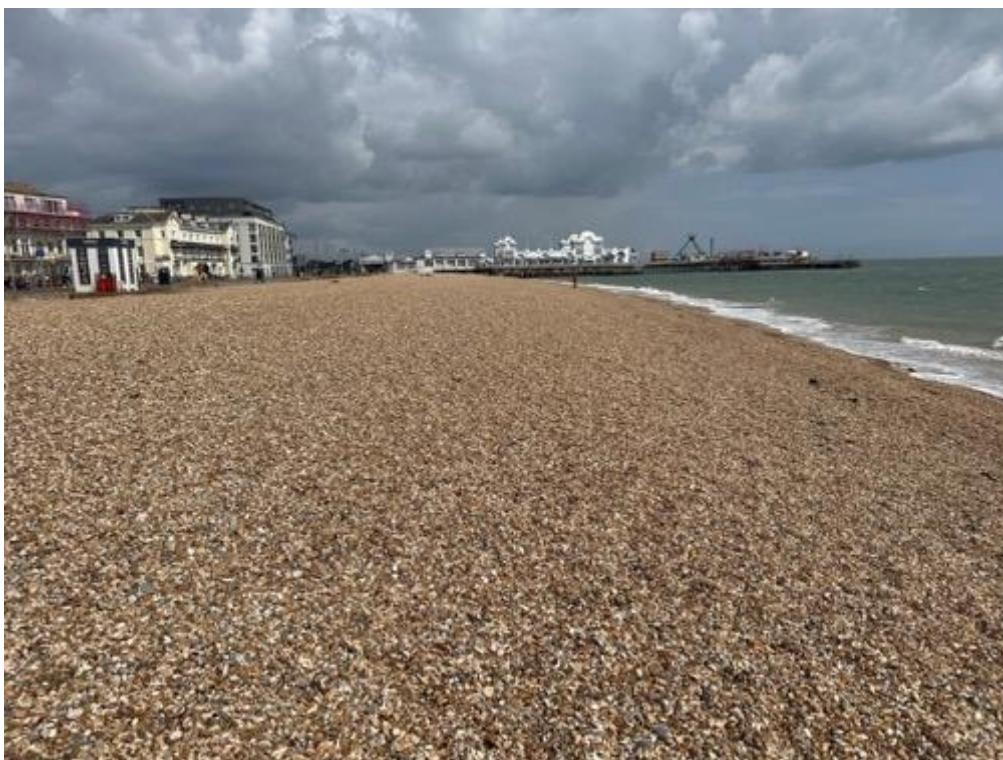
Photograph Z.2b.2 : Beach View Down to Clarence Pier

This section is less sandy but the busiest due to being the narrowest strip between the prom/parking and water, Photograph Plate Z.2b.2. Beach users can walk underneath the pier, Photographic Plate Z.2b.3. There is no obvious hazards presented by the pier or cut-off from the tide.

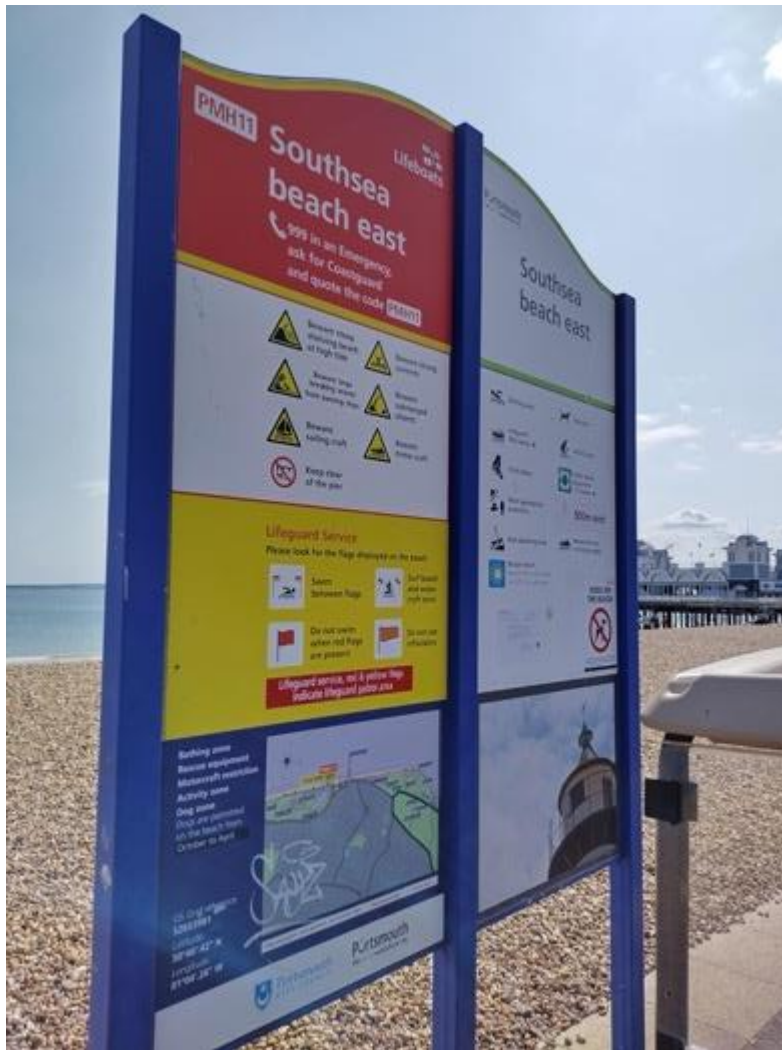
Photograph Z.2b.4: Primary RNLI signage

Main RNLI primary signage – Photographic Plate Z.2b.4

Retain current RNLI water safety signs and PRE at Canoe Lake and Coffee Cup. Replace sign with life ring symbol east of Pier.

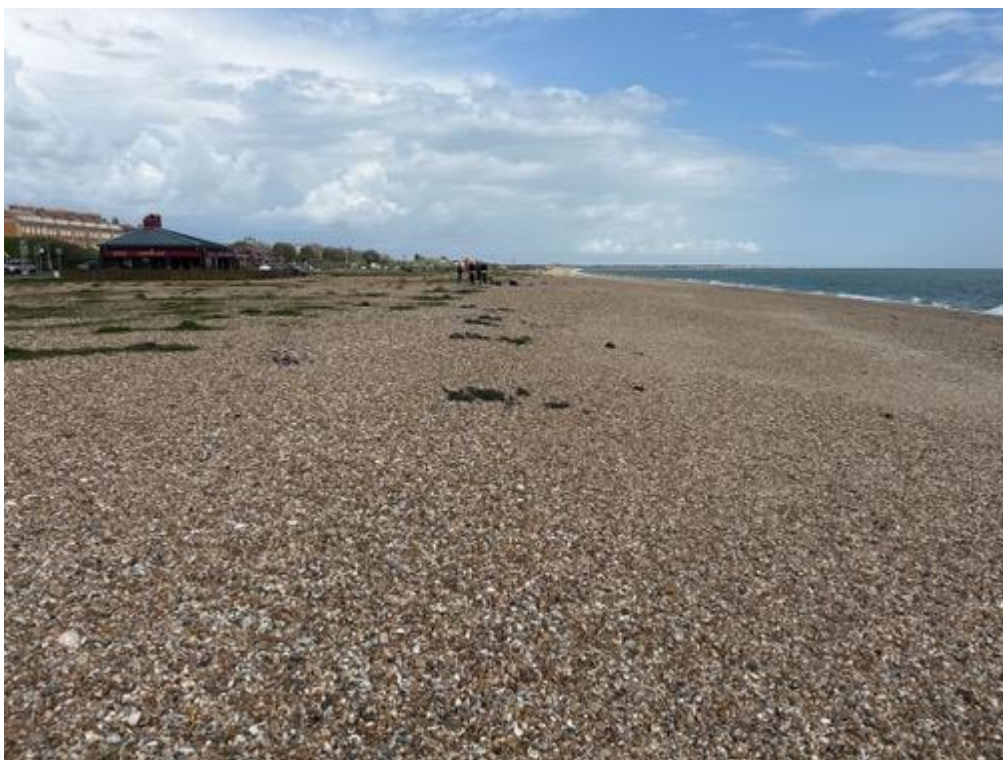
Photograph Z.3.1: Coffee Cup and PRE

This is a more remote part of Southsea beach front used mostly by local residents including dog walking, running, and peace and quiet. There is a promenade running along the beach. The beach is gently shelving, Photographic Plate Z.3.1.

The area starts with Coffee Cup which creates a central point and there is a PRE life ring adjacent, Photographic Plate Z.3.1. There are beach huts along this stretch. Dog walking during the summer is restricted west of Coffee Cup.

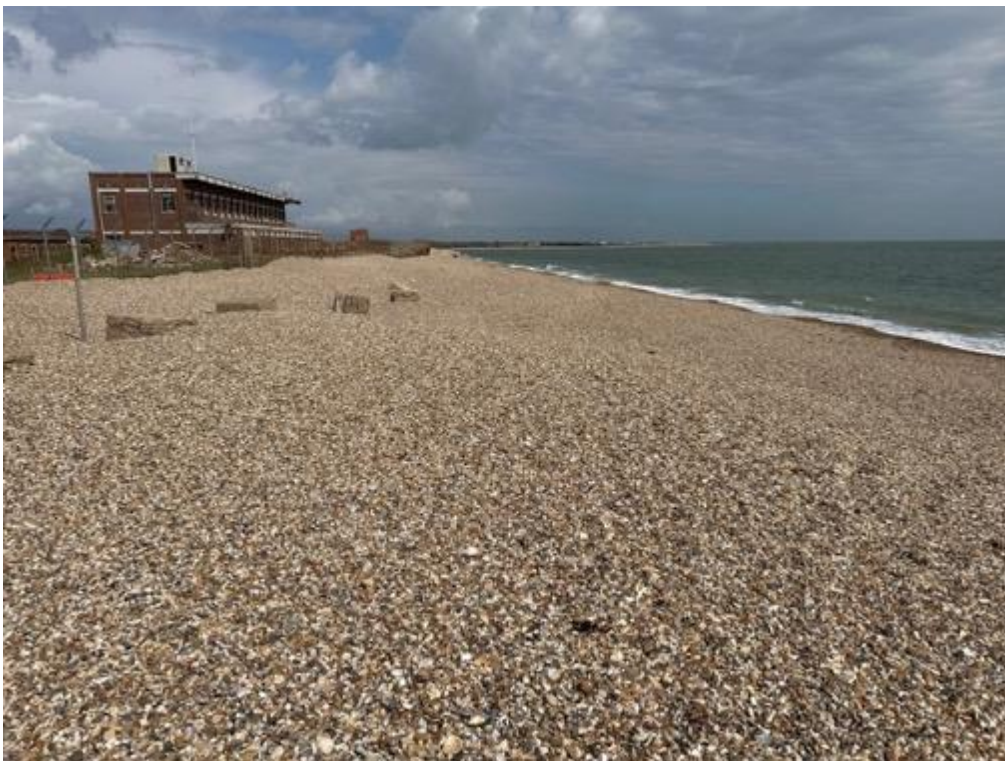
Photographic Plate Z.3.3: Naturist Beach

There is a naturist beach at eastern-most end, Photographic Plate Z.3.3.

Nothing at naturist beach/path cut through.

Place ring where path joins beach as swimming activity by naturists.

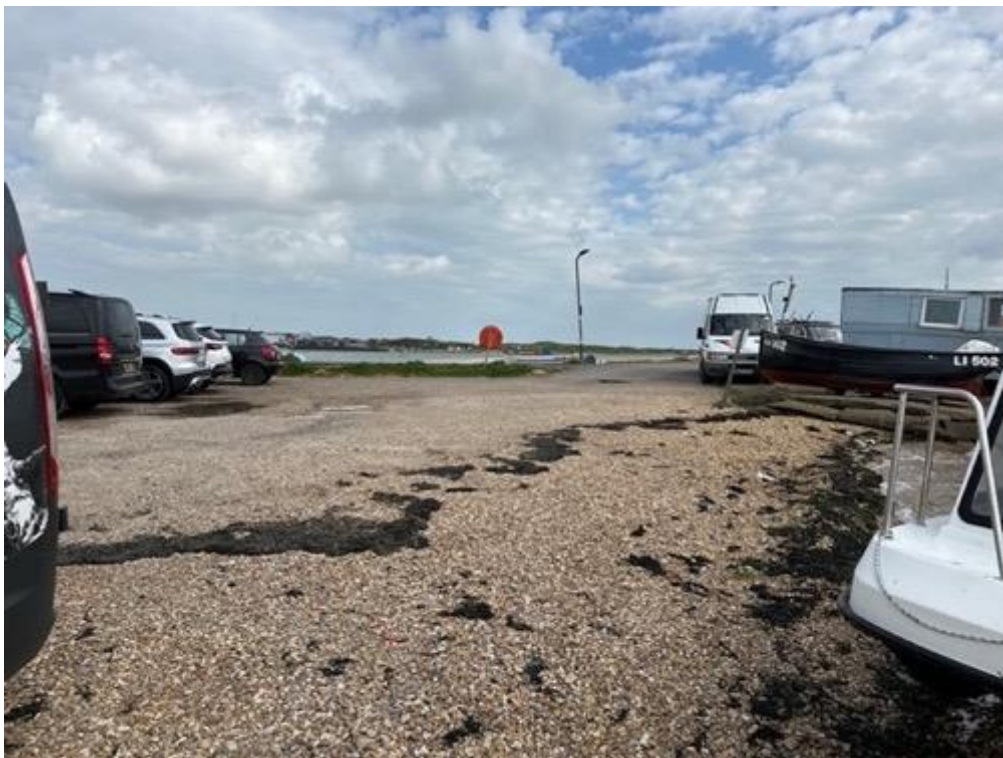
Photograph Z.4.1 PRE on top of Beach at Car Park

A very strong tide runs along this stretch and combined with steep gradient of beach, creating a drowning risk. There are a number of PRE appliances, e.g Photographic Plate Z.4.1.

There are a number of PRE appliances, including the one shown in Photographic Plate Z.4.1.

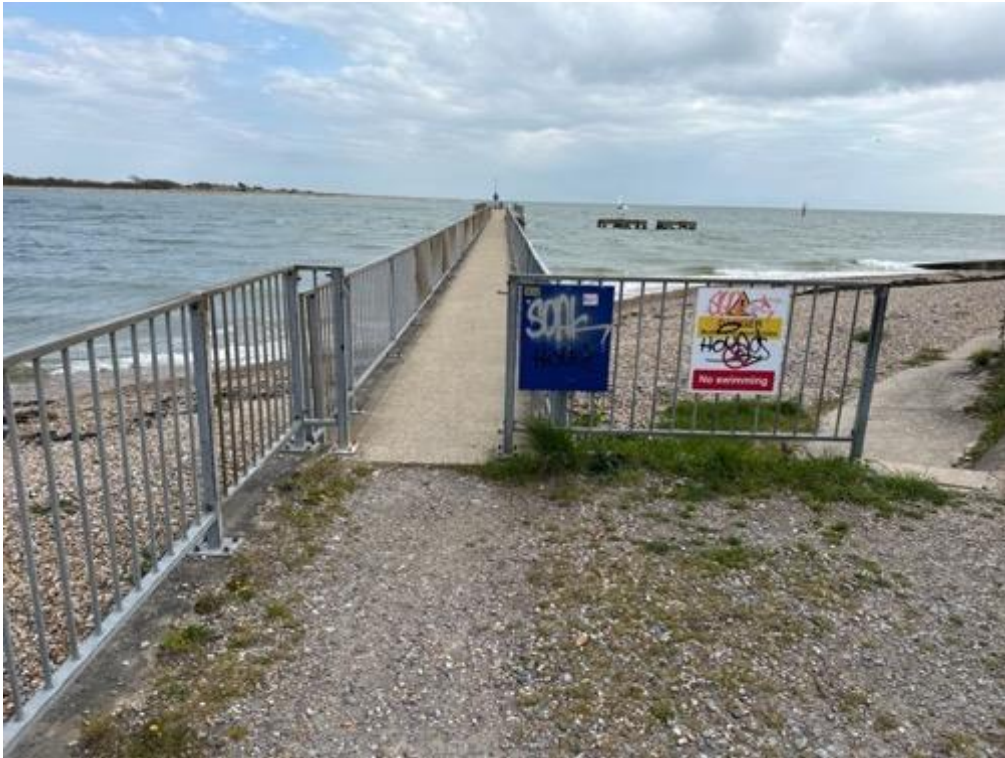
Photograph Z.4.2 Outfall and Signage

Southern Water outfall pier with walkway on top, Photographic Plate Z.4.2.

There is a main RNLI primary signage at the car park and a danger sign at the Southern Water Outfall, noting tides and outfall with no swimming, Photographic Plate Z.4.2.
No other signage present relating to beach conditions.

Place a life ring on the outfall, either halfway down or at the end if this is not possible.

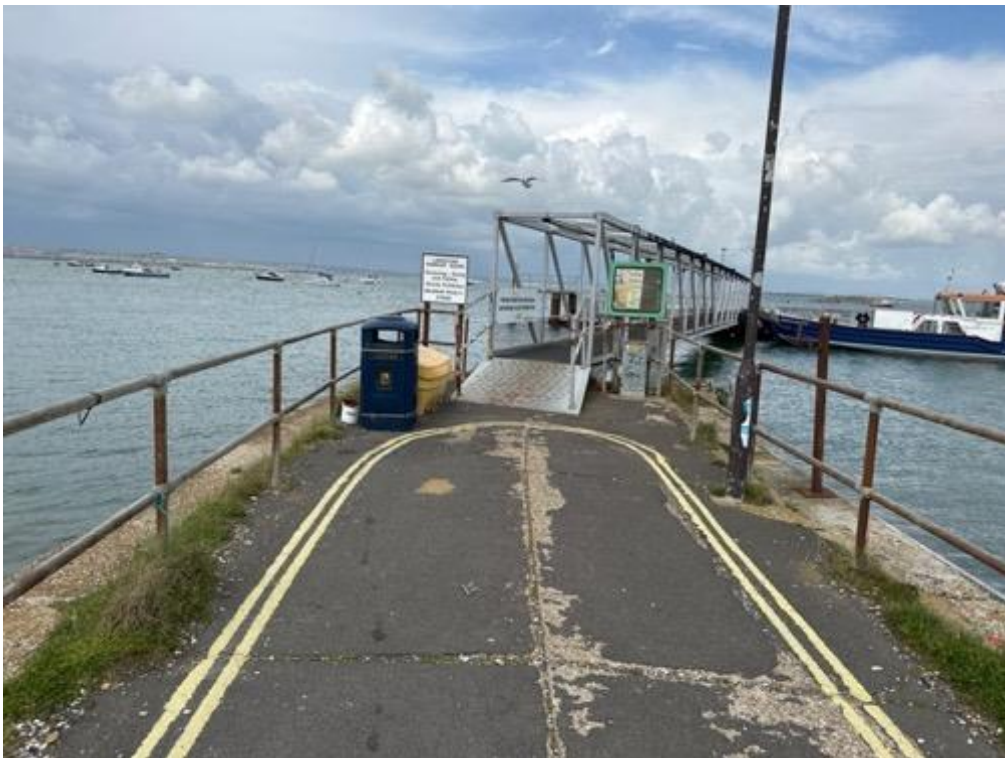
Photograph Z.4.3. Slipway Managed by Langstone Harbour Board

The slipway is not the responsibility of PCC, Photographic Plate Z.4.3.

This is not the responsibility of PCC but there are railings in place on the slipway and a prohibition no access sign. The edge of the water way opposite the slipway is shallow with no obvious hazards.

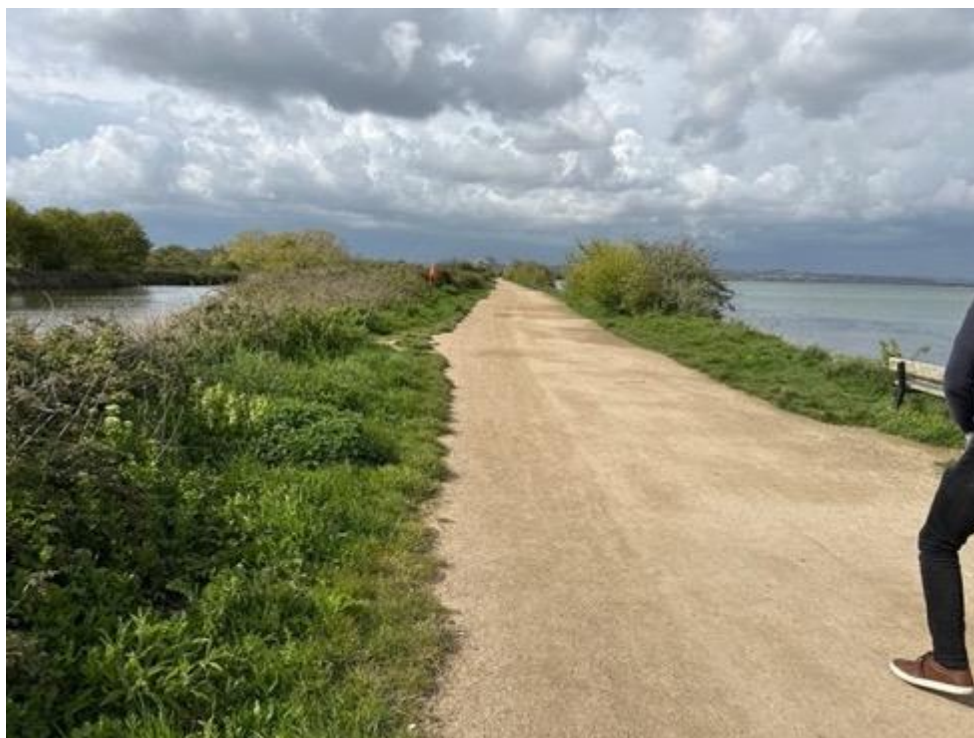
Photograph Z.5.1: Path between Swan Lake and Milton Common

The path is well managed and in good condition, running between the inland lakes and Milton Lake, PP.Z.5.1. Access to Milton Lake is defined by the rock armour PP.Z.5.2. Access to large sections of the lakes is restricted by natural vegetation, PP.Z.3. There are a number of access points between the vegetation.

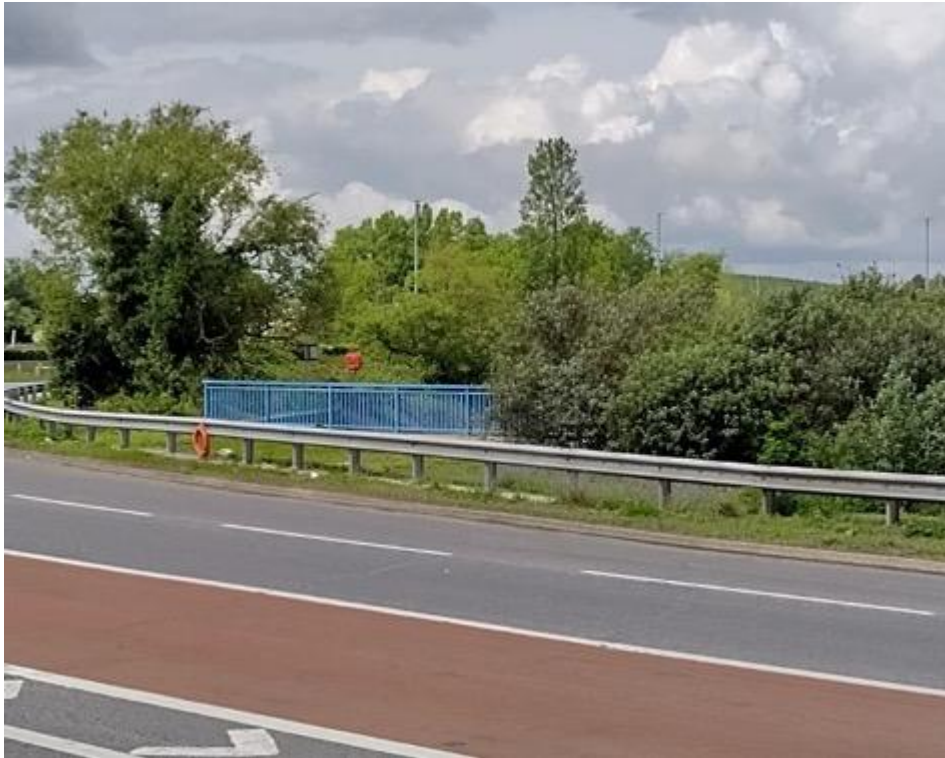
Photo Z7.1: PRE at Hilsea Roundabout obstructed by foliage

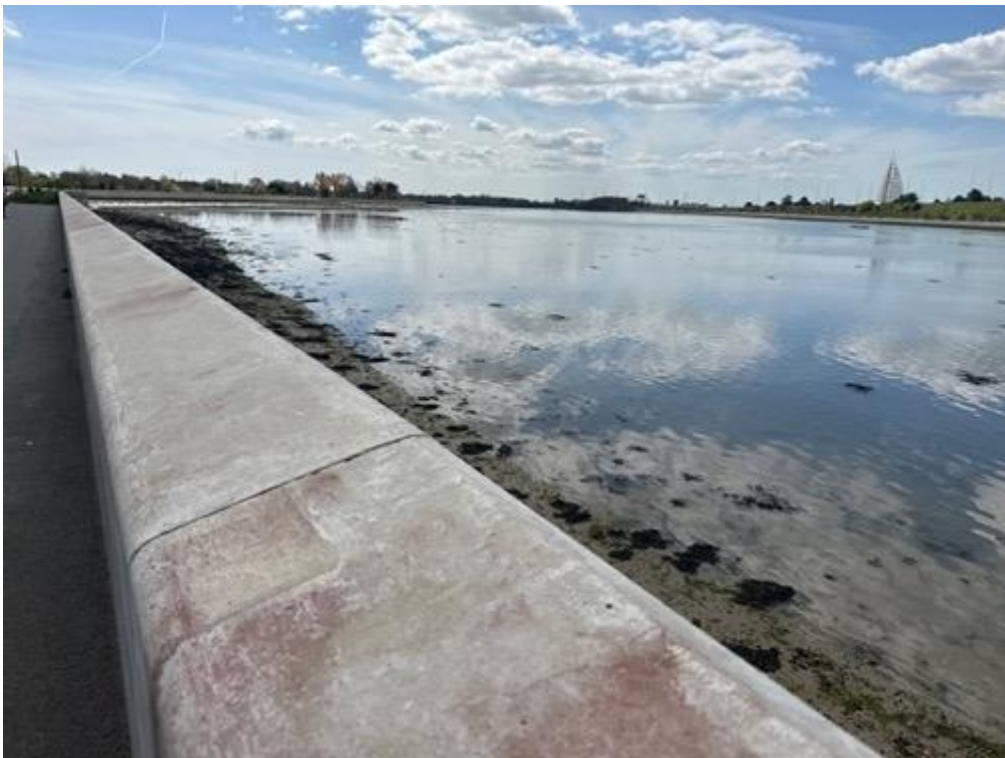
Photograph Z.8.3. Hard Engineered Edge Protection

Chest height coastal wall creating robust edge protection, Photographic Plate Z.8.3. There are numerous egress steps in good repair. These are necessary for people to exit the lake. On the motorway side the lake is shielded by fencing, Photographic Plate .Z8.4.
