ACCIDENT AND CASUALTY REPORT

Deep dive analysis

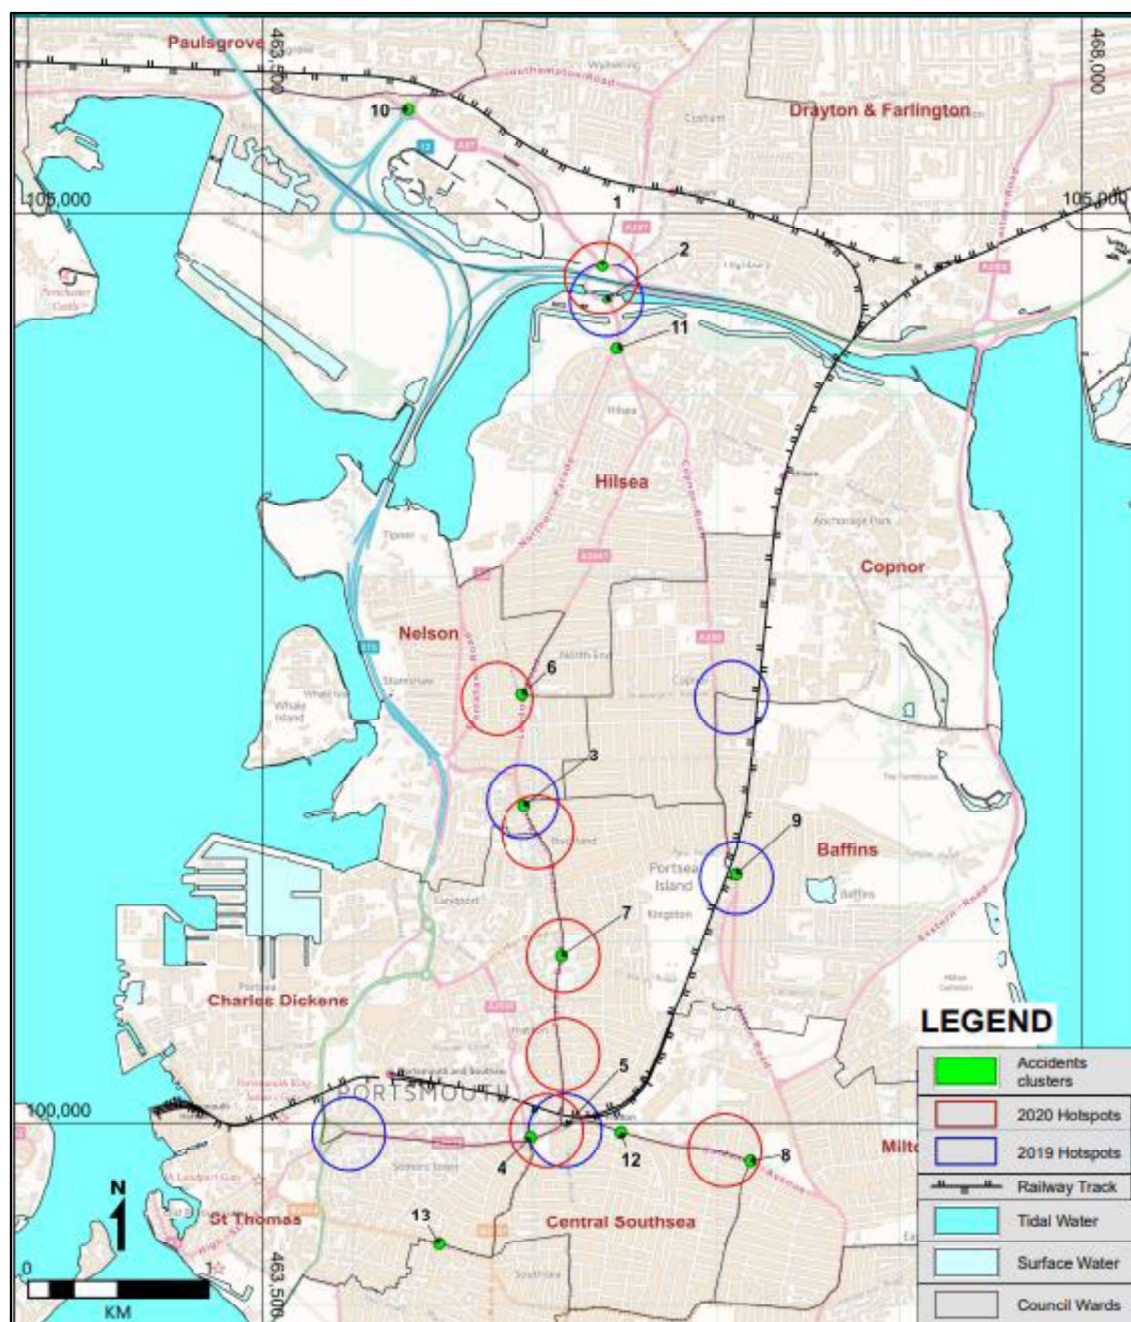
Map 1.1: Accidents hotspots and accident clusters in Portsmouth for 2019 and 2020

Map 1.1 outlines the hotspot areas discussed in the Accident and Casualty report 2021 whilst showing the smaller clusters where a greater density of accidents occur.

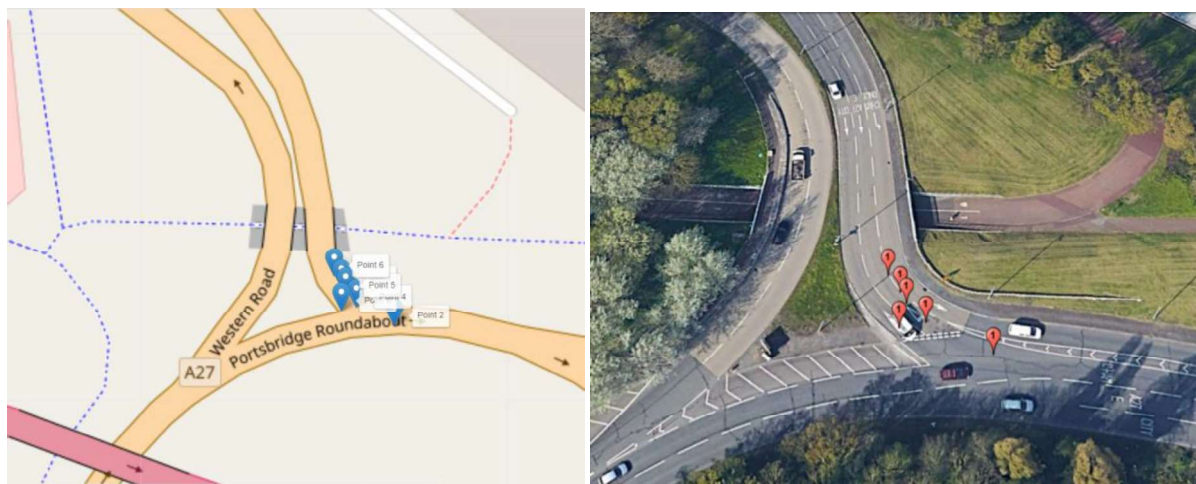
Image 2.1: Accident clusters located at A27 Western Rd junction with A397 Northern Rd.

Cluster type: Hotspot 2019 & 2020

Accidents in cluster: 2019 (2), 2020 (4)

- Failed to judge other persons path or speed (2)
- Failed to look properly (3)
- Sudden braking (1)

- Slight (6)

Findings: The cluster is within overlapping accident hotspots. The number of accidents clusters has doubled since 2019. Although the speed limit here goes up to 50mph and failure to look properly is the main cause of accidents, injuries from these accidents are minor. This is likely to mean that speed isn't an issue. Further analysis shows that the roads were dry with no high winds, and these incidents occurred on normal Give-Way or Uncontrolled roundabouts. This could mean visibility of signage is the issue. Looking at the double digit rise in accidents, we recommend a solution being implemented. The solution could be improving the drivers' ability to look properly when approaching the junction

outlined in Image 2.1 or raising the drivers' awareness through signage before they approach the risk area.

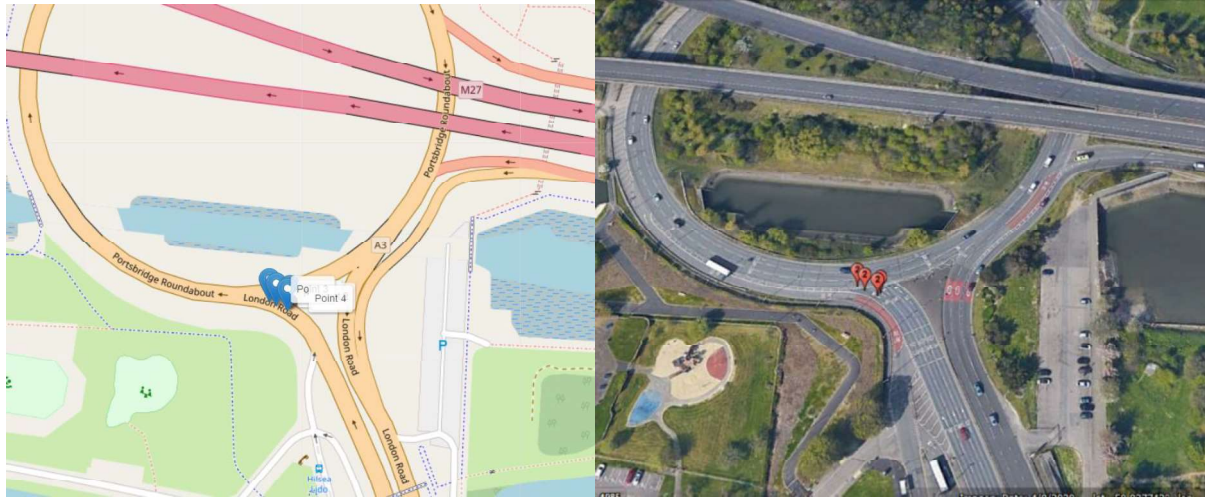
Image 2.2: Accident clusters located at A3 London Rd at junction with A27 Western Rd (Portsbridge Roundabout)

Cluster type: Hotspot 2019 & 2020

Accidents in cluster: 2019 (3), 2020 (1)

- Failed to judge other persons path or speed (2)
- Disobeyed Give Way or Stop sign or markings (1)
- Sudden braking (1)

- Slight (3)
- Serious (1)

Findings: The cluster is within overlapping accident hotspots. The number of accidents has dropped from 3 to 1 since 2019. The accidents occurred at a normal Give-Way or uncontrolled roundabout, under dry conditions, with speed limits between 30-40mph and the main cause being failure to judge other persons path or speed. This could mean the drivers became impatient, which led to the accidents. The data doesn't show any changes in the causes between 2019 and 2020. We recommend this area is monitored for accidents to evaluate if the volume of accidents in 2021 increase. If accidents increase with the same causal reason as 2019 & 2020 we recommend signage that would raise the drivers alertness as they approach the junction (Image 2.2).

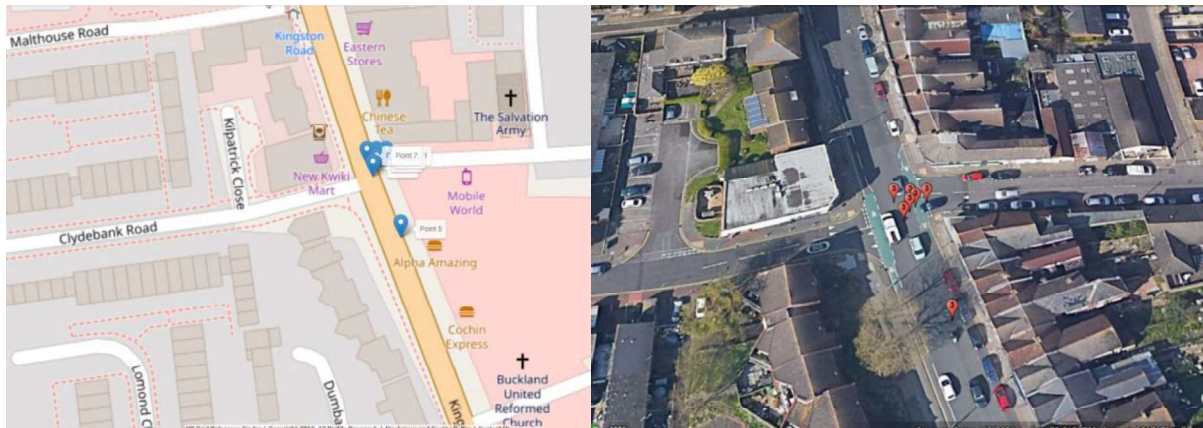
Image 2.3: Accident clusters located at Kingston Rd, Outside N° 192, North End.

Cluster type: Hotspot 2019 & 2020

Accidents in cluster: 2019 (3), 2020 (4)

- Poor turn or manoeuvre (1)
- Following too close (1)
- Failed to look properly (3)
- Failed to judge other persons path or speed (2)

- Slight (6)
- Serious (1)

Findings: The cluster is within overlapping accident hotspots. The cluster has 7 accidents with 6 of them occurring within 10m radius at the midpoint of the crossroads T-Junction. The accidents occurred during daylight, under dry conditions, at speeds limits between 20-30mph and at a Give-Way junction. Consequently we believe impatience seems to have played a significant role. Failure to look properly and misjudgement of others persons path or speed supports this assertion. We recommend an infrastructure change where the Road Safety Officer and Engineer discuss the way in which increases visibility of vehicles or signage is placed to raise awareness that this is a high profile accident location (Image 2.3), hence look properly before turning.

In the same trend, cluster Ref 3 is the 3rd highest risk location and cluster Ref 6 is the 4th highest risk zone for accidents in Portsmouth. This classification was also based on the accidents volume, growth different from 2019 - 2020, severity, casualty and the infrastructure characteristics seen from the satellite imagery.

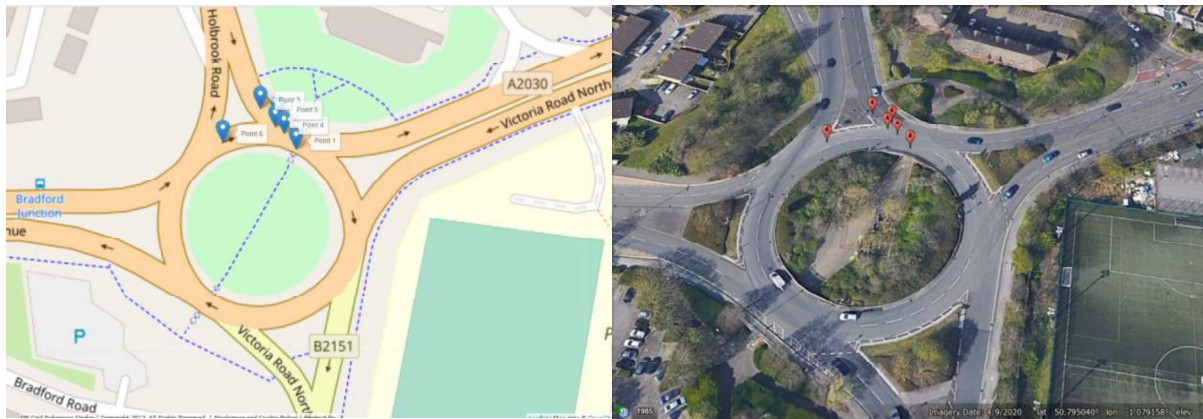
Image 2.4: Accident clusters located at A2030 Holbrook Rd junction with A2030 Victoria Rd North.

Cluster type: Hotspot 2019 & 2020

Accidents in cluster: 2019 (2), 2020 (4)

- Failed to judge other persons path or speed (1)
- Exceeding speed limit (1)
- Failed to look properly (3)
- Disobeyed Give Way or Stop sign or markings (1)

- Slight (5)
- Serious (1)

Findings: The cluster is within overlapping accident hotspots. The cluster has 5 out of the 6 accidents occurring at an entrance point to the Give-Way roundabout. In this cluster accidents have doubled from 2 in 2019 to 4 in 2020. Failure to look properly was given as the main cause of accidents here (Image 2.4). When grouping the other reasons there is a clear indication that a lack of procedure was shown in how to effectively join on to the roundabout. The good weather conditions, dry roads, daylight and visibility help eliminate possible natural or infrastructure reasons. Accordingly we recommend raising driver awareness to this being a high risk area for accidents through communications and signage.

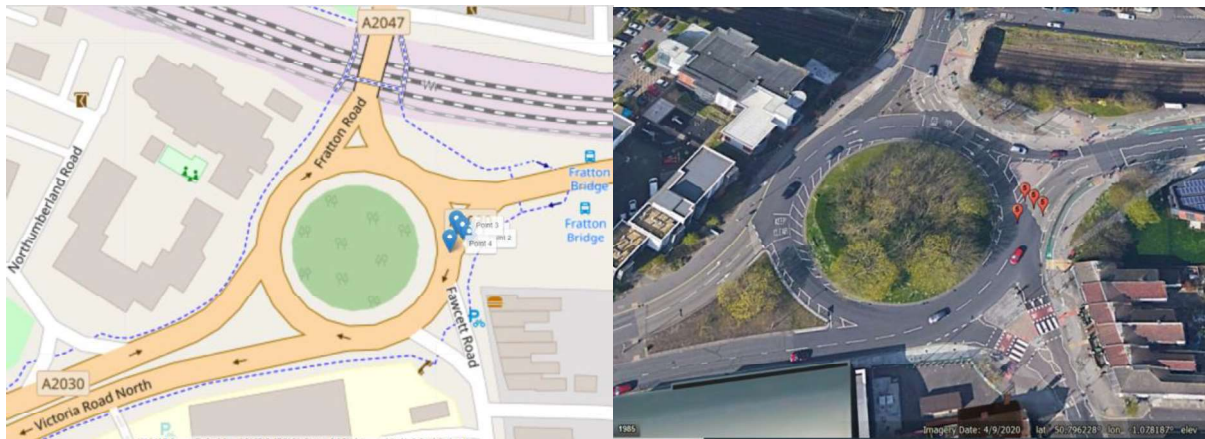
Image 2.5: Accident clusters located at A2030 Goldsmith Ave at junction with A2047 Fratton and Fawcett Rd.

Cluster type: Hotspot 2019 & 2020

Accidents in cluster: 2019 (2), 2020 (2)

- Failed to look properly (3)
- Disobeyed Give Way or Stop sign or markings (1)

- Slight (3)
- Serious (1)

Findings: The cluster is within overlapping accident hotspots. This particular cluster has only 4 accidents but was included in this report because of its nature. 3 of the accidents occurred on a horizontal line and less than 2 meters distance from each other. One of the accidents in this cluster occurred in the night under rainy conditions, however the presence of lighted street lights at this point (Image 2.5) dismisses possible visibility difficulties. The driver's inability to look properly was again cited as the main reason for these accidents. We recommend reviewing this cluster in 2021 to evaluate if the problem still exists. If the problem is still there we believe relevant signage could raise driver awareness and reduce the accident volume.

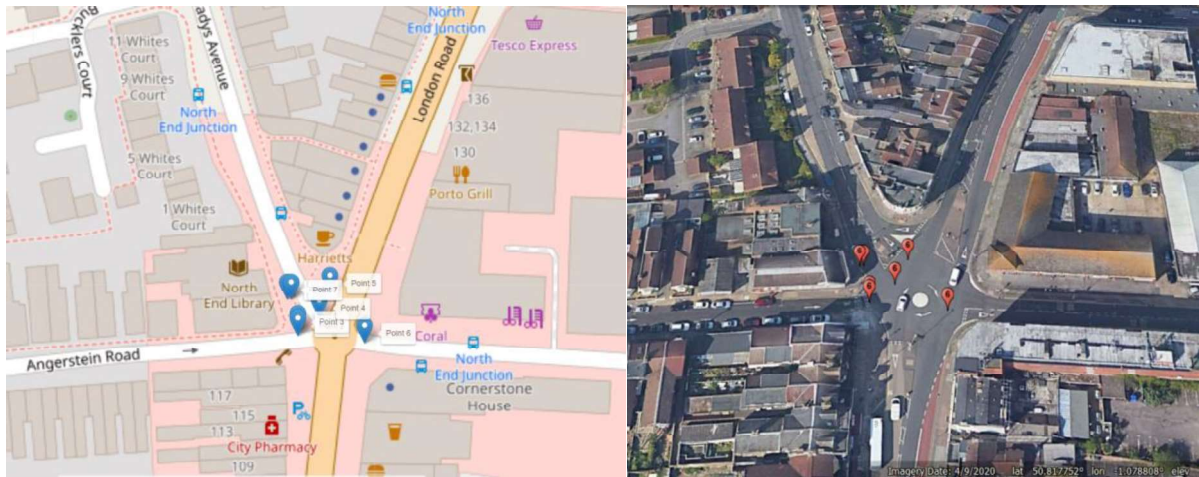
Image 2.6: Accident clusters located at A2047 London Rd at roundabout junction with Stubbington Ave

Cluster type: Hotspot 2020

Accidents in cluster: 2019 (2), 2020 (5)

- Failed to look properly (4)
- Failed to judge other persons path or speed (1)
- Disobeyed Give Way or Stop sign or markings (1)
- Poor turn or manoeuvre (1)

- Slight (5)
- Serious (2)

Findings: This cluster is within a 2020 accident hotspot. The accidents here are sparsely distributed on the north-west section of the roundabouts. There is a spike in accidents here from 2 in 2019 to 5 in 2020. Although the speed limit (30mph), visibility, road conditions and junction type remains the same, the 2 serious accidents occurred in 2020. 2 pedestrians and 4 cycles were also involved. Proper observation problems were once again named as the main cause of these incidents. Looking at sparseness of the accidents across the roundabout, we recommend a review of the infrastructure of this roundabout (Image 2.6). There are a significant number of cycle accidents in this cluster, thus we recommend a collaborative approach between the Active Travel Officers, Road Safety Officer and technical Engineer when evaluating the infrastructure. The placement of relevant signage may raise awareness to reduce accident volumes.

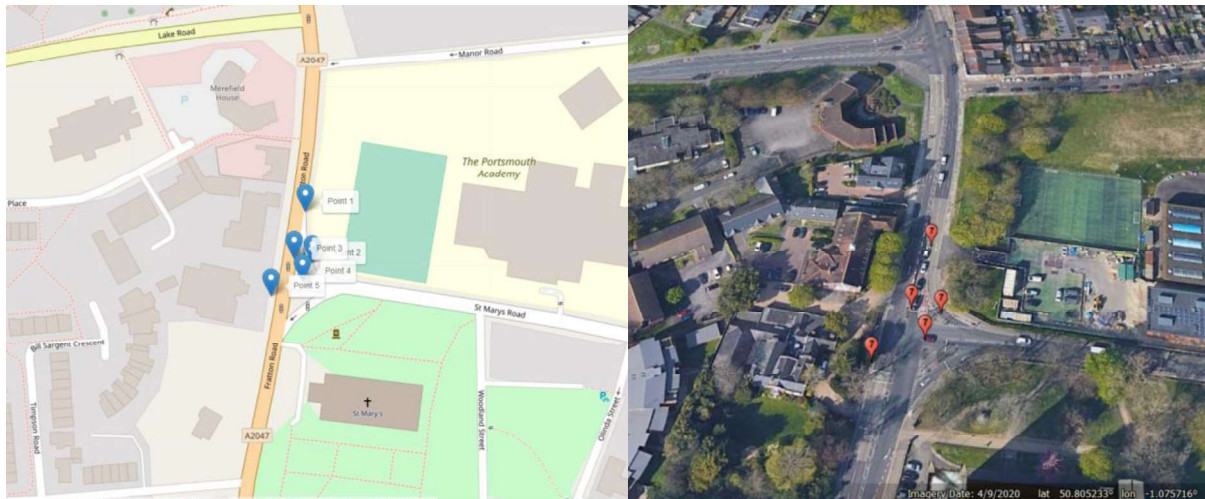
Image 2.7: Accident clusters located at A2047 Fratton Rd Junction with St Marys Rd.

Cluster type: Hotspot 2020

Accidents in cluster: 2019 (1), 2020 (4)

- Sudden braking (1)
- Impaired by alcohol (2)
- Poor turn or manoeuvre (1)
- Failed to look properly (1)

- Slight (3)
- Serious (2)

Findings: This cluster is within a 2020 accident hotspot. 3 accidents were located at the T-Junction and two on the north and south entrance to the junction. This cluster has been included in the analysis because of the sharp increase in accidents from 1 in 2019 to 4 in 2020 as well as its severity. The accidents occurred under dry conditions, distributed around the T-Junction and with a speed limit of 30mph. Drunkenness is identified as the main cause and this indicates the presence of bars in the neighbourhood. We advise this area is monitored to evaluate if accidents continue to occur in this cluster during 2021. If accidents continue with the same causes we advise signage that raises awareness on the impact of drinking placed at this junction (Image 2.7) and a stop sign board that oblige drivers to halt their cars completely before making the crossing.

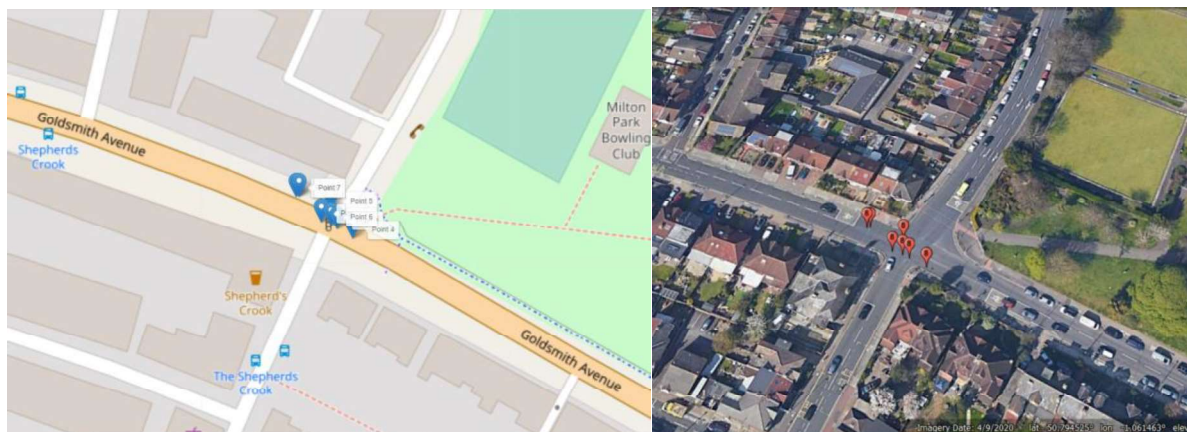
Image 2.8: Accident clusters located at A2030 Goldsmith Ave at Crossroads junction with Priory Crescent, Southsea.

Cluster type: Hotspot 2020

Accidents in cluster: 2019 (3), 2020 (4)

- Failed to look properly (4)
- Careless/Reckless/In a hurry (2)
- Failed to judge other persons path or speed (1)

- Slight (7)

Findings: This cluster is within a 2020 accident hotspot. This cluster involves 2 accidents occurring under darkness in 2019 with a cyclist involved. All 7 accidents took place under fine weather, with no high winds and dry roads at a crossroad with an automatic traffic signal. The slight severity of the accidents may be related to the 30mph speed limit. The slight increase in accidents from 3 to 4 from 2019 to 2020 shows that improvement at this junction (Image 2.8) is required to reduce the volume of accidents in this area. We recommend the installation of signage that obliges drivers to stop, hence giving the time needed to look properly before making the crossing.

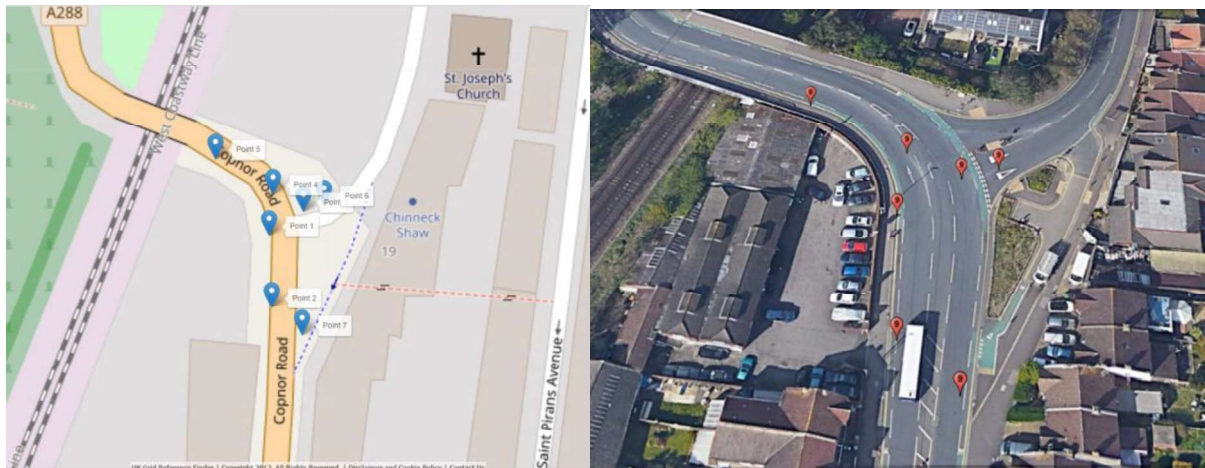
Image 2.9: Accident clusters located at A288 Milton Rd junction with Tangier Rd.

Cluster type: Hotspot 2019

Accidents in cluster: 2019 (4), 2020 (3)

- Illness or disability, mental or physical (1)
- Careless/Reckless/In a hurry (2)
- Failed to look properly (3)
- Deposit on road (oil, mud, chippings) (1)

- Slight (5)
- Serious (2)

Findings: This cluster is within a 2019 accident hotspot. Most of the accidents occurred at the central part of the staggered Give-Way junction. The severity of most of these accidents was slight maybe because they took place under daylight, with fine weather (no high winds), dry roads and where speed limits was 30mph. These accidents were mainly categorised as careless, reckless and in a hurry drivers and failure to look properly. Based on these findings, we propose a measure that raises awareness of an impending danger when drivers are approaching this junction (Image 2.9). A stop sign that obliges drivers to halt completely will provide the time needed to look properly before making the crossing.

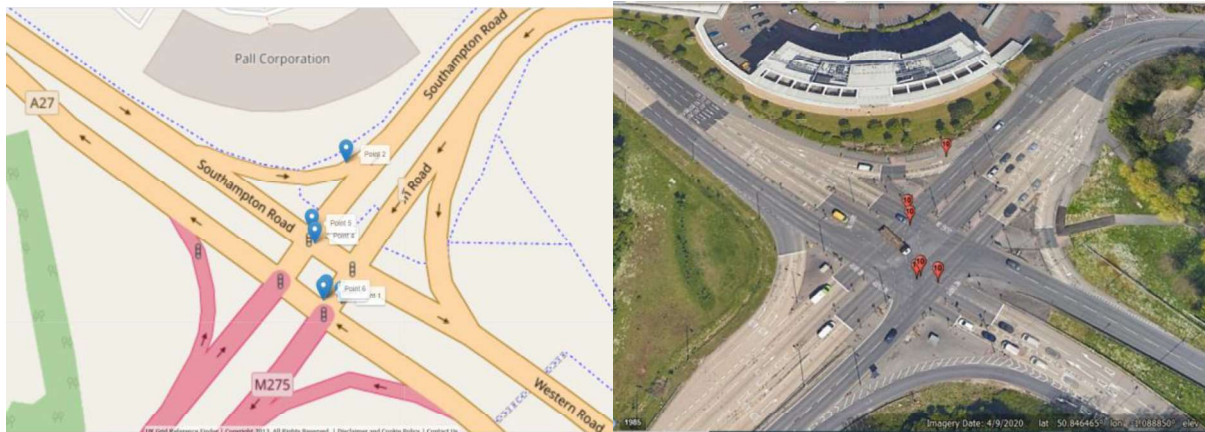
Image 2.10: Accident clusters located at A27 Southampton Rd junction with M27 Junction 12 Off slip.

Cluster type: None hotspot area

Accidents in cluster: 2019 (3), 2020 (3)

- Careless/Reckless/In a hurry (1)
- Poor turn or manoeuvre (1)
- Exceeding speed limit (1)
- Defective brakes (1)
- Failed to look properly (1)
- Impaired by alcohol (1)

- Slight (4)
- Serious (2)

Findings: This cluster is not within a hotspot but it has a density of 6 accidents within 30m².

The number of casualties in this cluster (Image 2.10) is the highest in Portsmouth and it lays along a major road. The reasons for these accidents are diverse and all took place at crossroads with automatic traffic signals. A deeper look into the conditions prevailing at the time shows that, 50% occurred under darkness between 13h00 - 22h00, in 40mph speed limit zone and the roads were largely dry. While 5 of the accidents occurred at the centre of the junction, one related to excess speed went off the track before crashing. Considering that the number of accidents haven't changed from 2019 to 2020, the diverse reasons for the accident and the excellent infrastructure, we think signage that raises awareness of an impending danger close to the junction on all sides may reduce accidents.

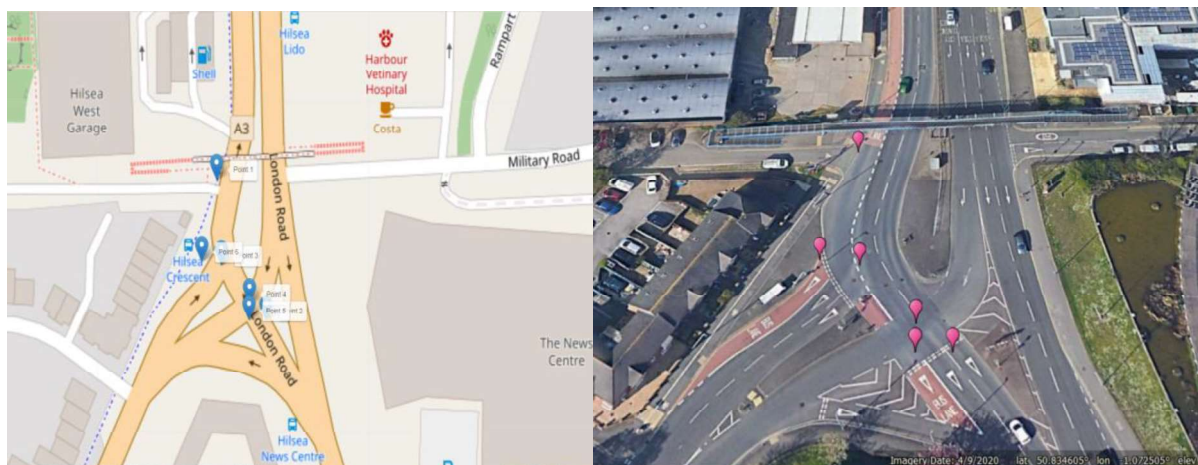
Image 2.11: Accident clusters located at A3 London Rd junction with A3 Northern Parade

Cluster type: None hotspot area

Accidents in cluster: 2019 (3), 2020 (3)

- Disobeyed Give Way or Stop sign or markings (1)
- Poor turn or manoeuvre (1)
- Slippery road (due to weather) 1
- Failed to judge other persons path or speed (1)
- Careless/Reckless/In a hurry (1)
- Following too close (1)

- Slight (6)

Findings: This cluster is not within a hotspot but it has a density of 6 accidents within 30m². The casualties here are second highest in Portsmouth for accidents clusters of 30m². Most of these accidents occurred on a wet road, at a Give-Way T-Junction, under the cover of darkness and where the speed limit is 30mph. They caused only slight injuries (6) with 1 cyclist involved. The accidents are sparsely distributed, with no main reason for their occurrences and no change over two years. Consequently we advise this area is monitored via 2021 data and we propose a review of the road infrastructure and road signs at this location (Image 2.11).

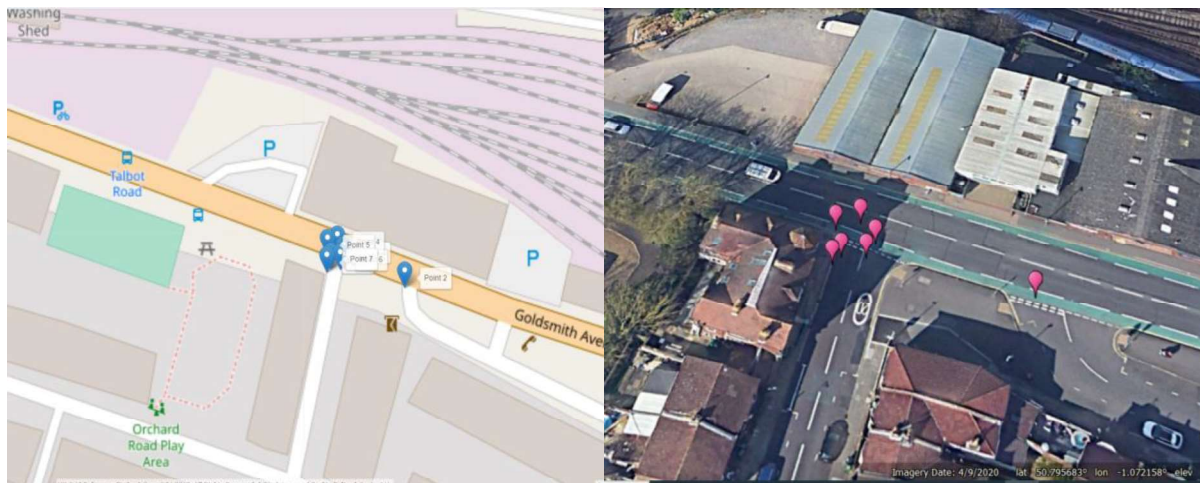
Image 2.12: Accident clusters located at A2030 Goldsmith Ave, junction with Talbot Rd, Southsea.

Cluster type: None hotspot area

Accidents in cluster: 2019 (2), 2020 (5)

Failed to look properly (4)
Careless/Reckless/In a hurry (1)
Poor turn or manoeuvre (1)
Slippery road (due to weather) (1)

- Slight (5)
- Serious (2)

Findings: Like the previous two cases (cluster 10 and 11), cluster 12 is not within a hotspot but has 7 accidents within 30m² with 6 below 10m² to each other. These highly clustered accidents occurred at a staggered Give-Way or uncontrolled roundabout, when the road was sometimes wet and where the speed limit is 30mph. Accidents at this location (image 2.12) have more than doubled from 2019 to 2020 with one pedestrian and 3 cyclists involved. Failure to look properly accounts for most of the occurrences. With this sharp rise in accidents, we recommend the slippery element of the road is investigated in line with typical cyclist tyres. Moreover relevant signage is placed to raise awareness of taking care at this junction. Although the volumes are small when compared with total accidents across the city the high proportion of accidents in this cluster radius factored with over 100% growth requires this site to be prioritised.

The characteristics of Cluster Ref 12 are similar to that of cluster 13 and has been ranked 2nd in terms of high risks locations and the 2nd priority location for anti-accident measures implementation. Again, information contained in table 1, graph 1 and 2 and image 2.12 shows that cluster 12 located at A2030 Goldsmith Ave, junction with Talbot Rd, Southsea, has the second highest volume of accidents, the widest growth difference in accidents from 2019 to 2020; a high number of serious accidents, above average number of casualties and infrastructure issues illustrated by poor visibility when entering the junction.

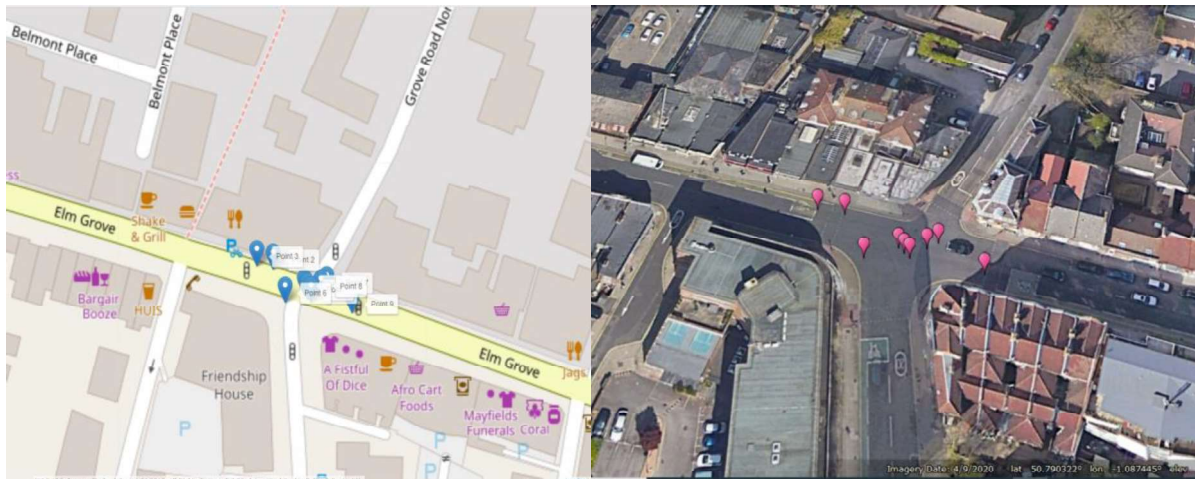
Image 2.13: Accident clusters located at Elm Grove at Crossroads junction with Grove Rd South & Grove Rd North, Southsea.

Cluster type: None hotspot

Accidents in cluster: 2019 (4), 2020 (5)

Poor turn or manoeuvre (3)
Failed to look properly (4)
Disobeyed Give Way or Stop sign or markings (1)
Disobeyed automatic traffic signal (1)

- Slight (7)
- Serious (2)

Findings: This cluster of accidents is not in a hotspot but is the second location in Portsmouth to have 9 accidents and 9 casualties within 30m2. This cluster is different from the others as its accidents involve 2 pedestrians and up to 5 cyclists. Poor turn or manoeuvre and failure to look properly have been identified as the two main causes of accidents here. We advise the Active Travel Officers, Road Safety Officer and a technical Engineer discuss the infrastructure of this road to evaluate the way in which to reduce accidents. When looking at the factors that caused these accidents and the infrastructure, we concluded visibility and driver error will continue to be prevalent in this area, consequently this is a high priority site where we need to prioritise safety.

From the analysis, four locations have significant road safety concerns that needs to be addressed to ensure that the safety of resident's remains at the forefront of the Transport Department's priorities. As seen in Table 1, Graph 1 and 2, and Image 2.13, Cluster Ref 13 located at Elm Grove at Crossroads junction with Grove Rd South & Grove Rd North, Southsea is the first location of concern with the highest risk for accidents. It is classified as such because of the following factors: it has the highest volume of accidents, the second widest growth difference in accidents from 2019 to 2020; high casualty numbers, a high number of serious accidents and poor infrastructure of the roundabout. Thus, Cluster Ref 13 has been given a priority rating of 1 in terms of anti-accident measures implementation.

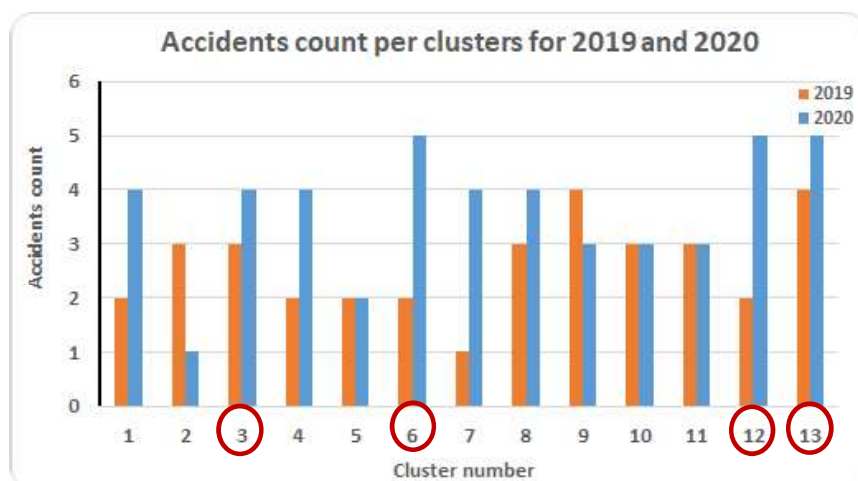
Chart 1: Accidents clusters for 2019 and 2020

This graph highlights the growth of accidents in certain clusters year on year and the distribution of volume of accidents by cluster by year.
