atlantic crest

Appendix 3

Risk Management of Inland Sites

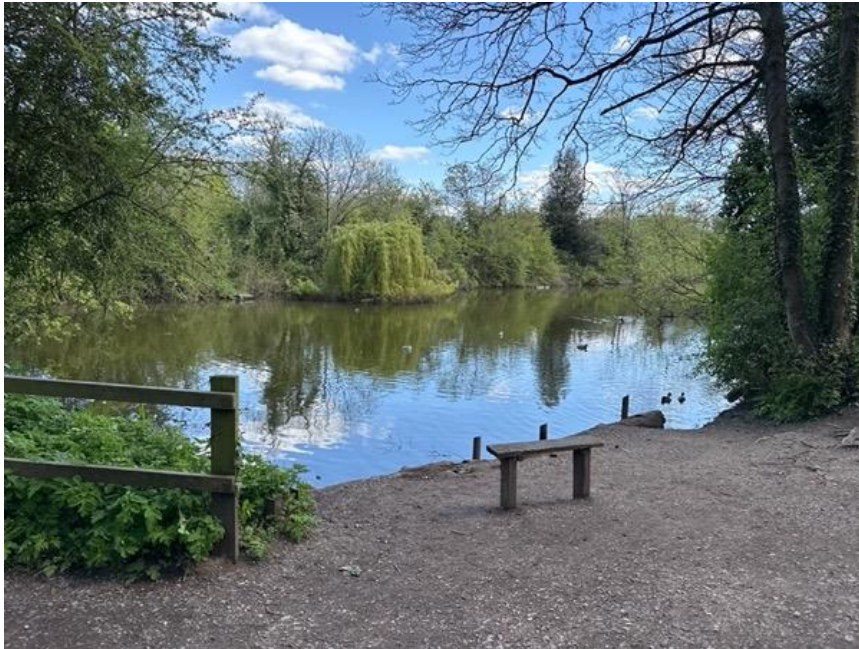
There are access points which are clearly marked, Photographic Plate 1. The lake has natural edge protection along a wide length of the lake, Photographic Plates 1 and 2.

Photograph 1 : Clearly Defined Access to Water

Create working group and consider removing PRE due to location, vandalism and no history of water activity. Continually monitor through the year with quarterly audits.

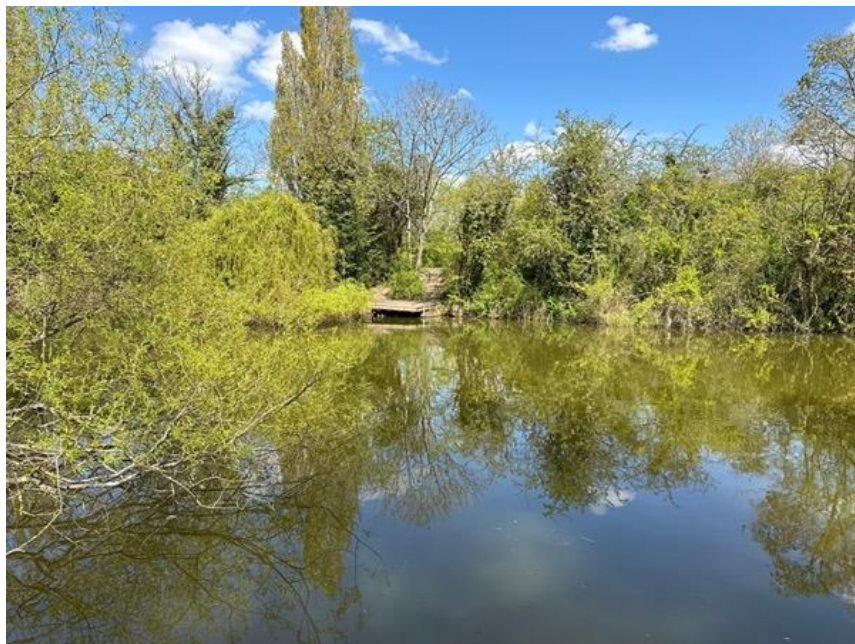
Photograph 2 : Natural Edge Protection and Fishing Peg

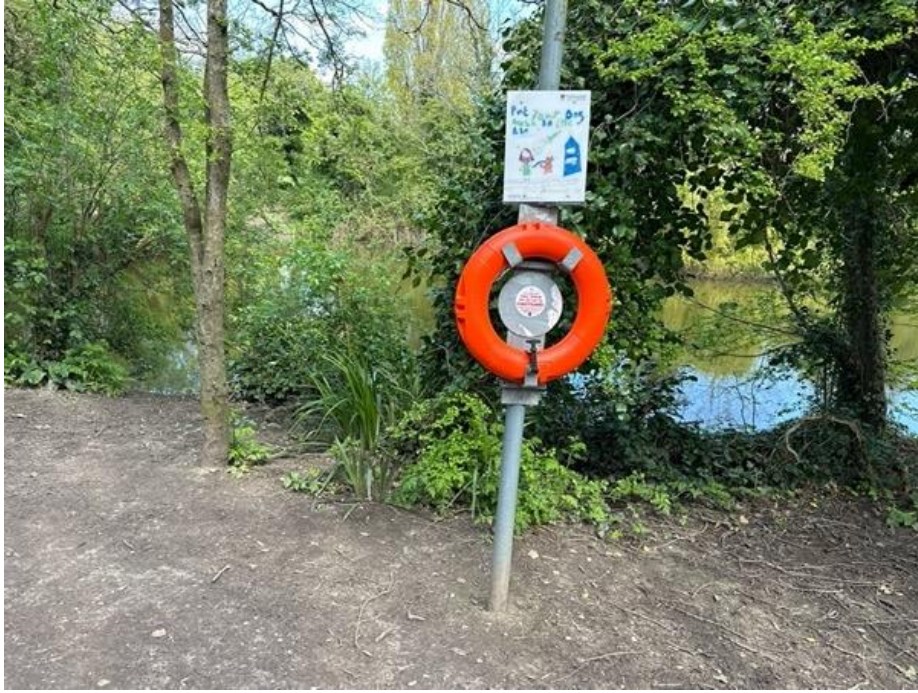
Life rings present at certain points, but often missing or in pond through vandalism, Photographic Plate 3.

Photograph 3 : Life Ring

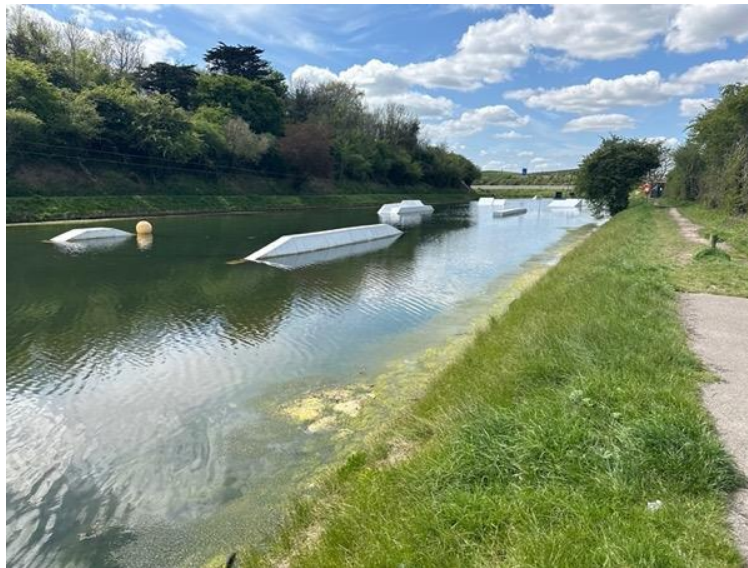
The path around the water body is away from the water margin and in general stable, Photographic Plates 1 and 2.

Photograph 1 : Wakeboard Park

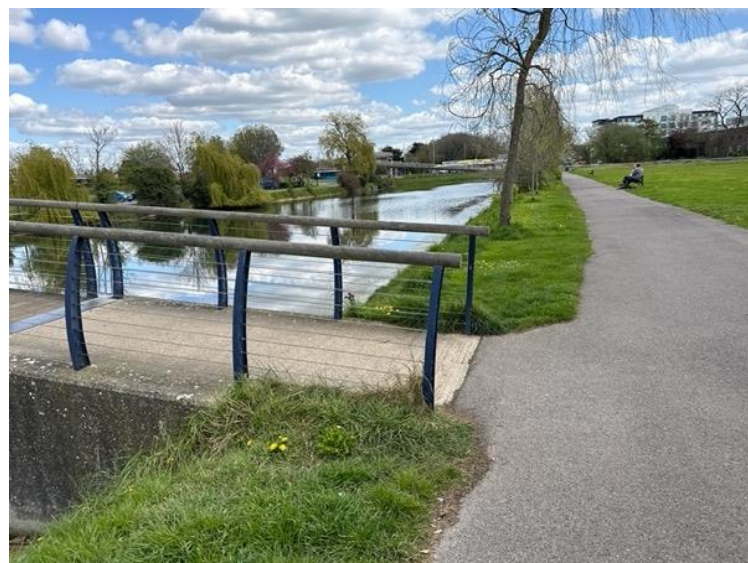
Photograph 2 : Bridge Across Waterbody

Place a similar sign to the chalk pits on either side of the foot bridge and at seating positions, Photographic Plate 2.

Place one PRE at the bridge and one at the seating positions which covers access points and congregation point.

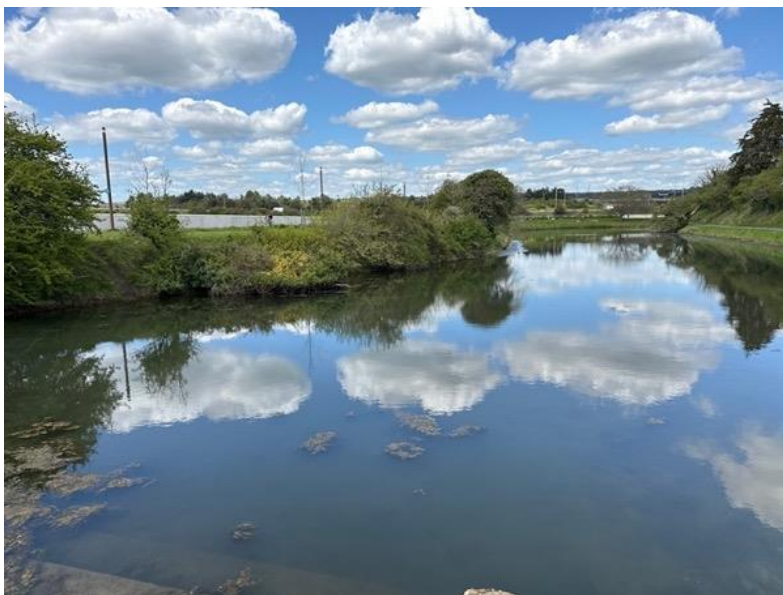
There is grass bank gradient down to narrow block ledge before water. There is natural edge protection on south side, Photographic Plate 3. There is limited risk that you could fall into the water. Any immersion would be through choice.

Photograph 2 : Lake Banks

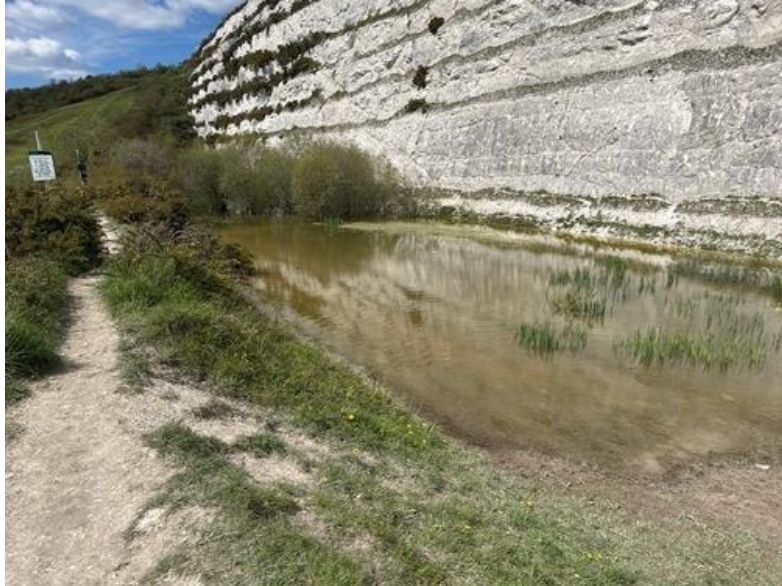
The pond is shallow with no hidden drops into the water. The water margin is clear, Photographic Plate 1.

Photograph 1: Clear water edge

No changes. Continually monitor for changes to the environment with at least quarterly visits.

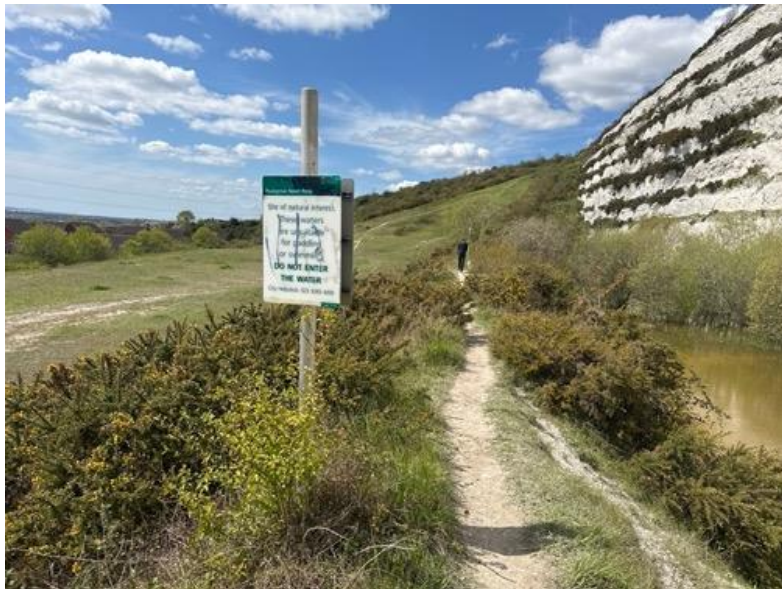
PCC info sign advising site of natural interest and not to go in the water. 'These waters are not suitable for paddling or swimming. Do not enter the water', Photographic Plate 2.

Photograph 2: Water Safety Sign
