atlantic crest

Appendix 3

Risk Management of Inland Sites

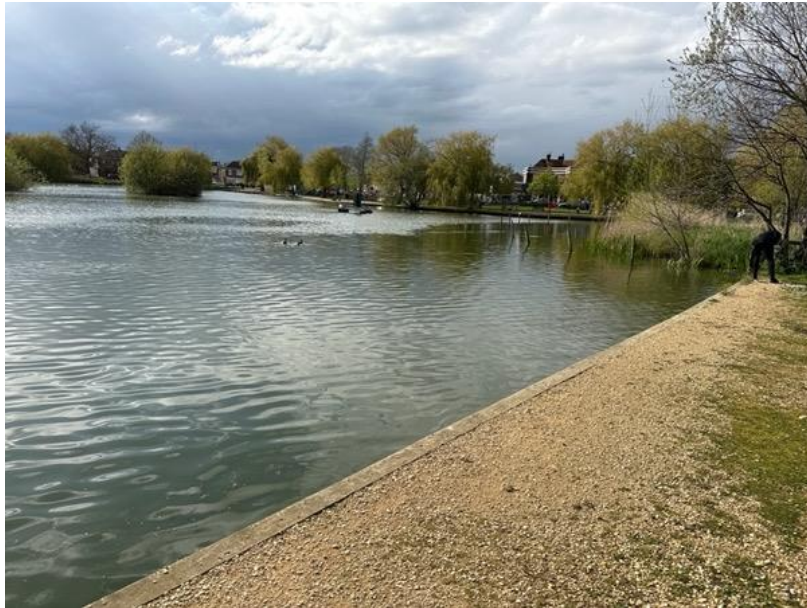
There is good, delineated edge protection with no hidden drops into the water, Photographic Plate 1 and there is also natural edge protection, Photographic Plate 2.

Photograph 1. Clear : Edge Protection

Consider removing the PRE life rings because it is shallow. Continually monitor for changes to the environment with at least quarterly visits.

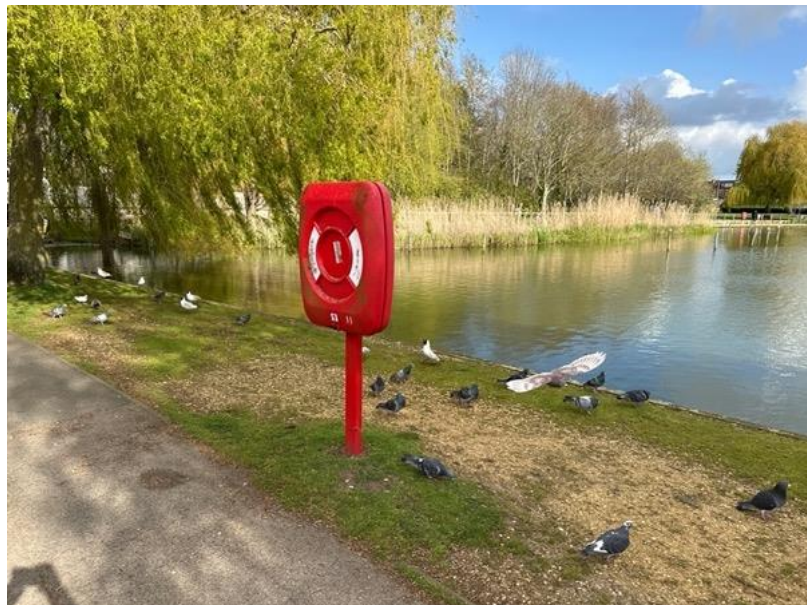
Frequent life ring presence, Photographic Plate 2, on 3x fishing platforms and 2x duck feeding area.

Photograph 2 : Liferings around the Pond

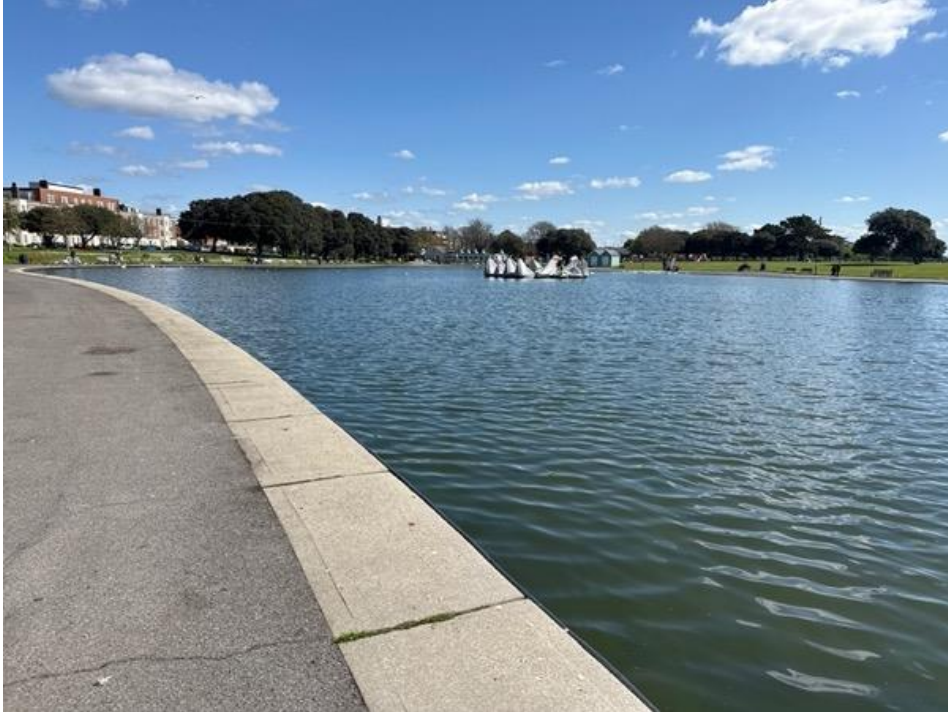
There is a clearly delineated edge to the lake and in a good state of repair, Photographic Plate 1.

Photograph 1 : Canoe Lake with Good Edge Protection

Remove the 5 PRE life rings. Continually monitor for changes to the environment with at least logged quarterly visits.

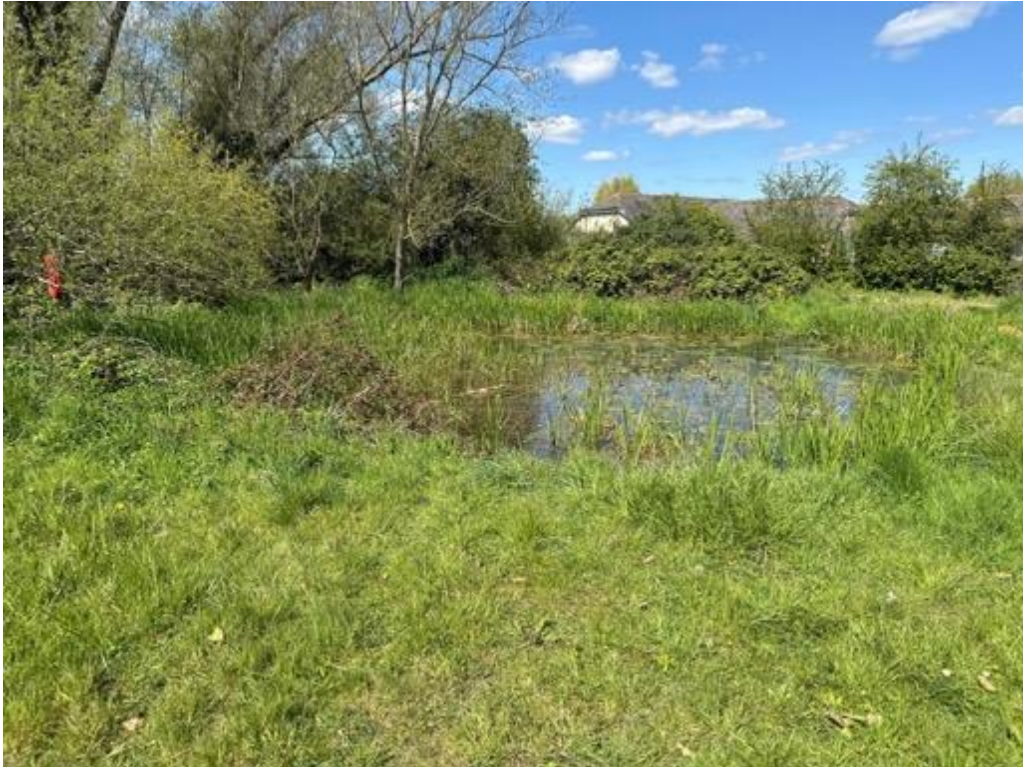
Half of the pond has natural edge protection. There are no hidden drops into the water. The water margin is clear, Photographic Plate 1.

1 PRE lifebuoy on post but inaccessible and not usable, Photographic Plate 1.

Photograph 1 : Shallow Pond with Natural Edge Protection and PRE

Remove PRE life buoy and do not replace. Continually monitor for changes to the environment with at least quarterly visits.

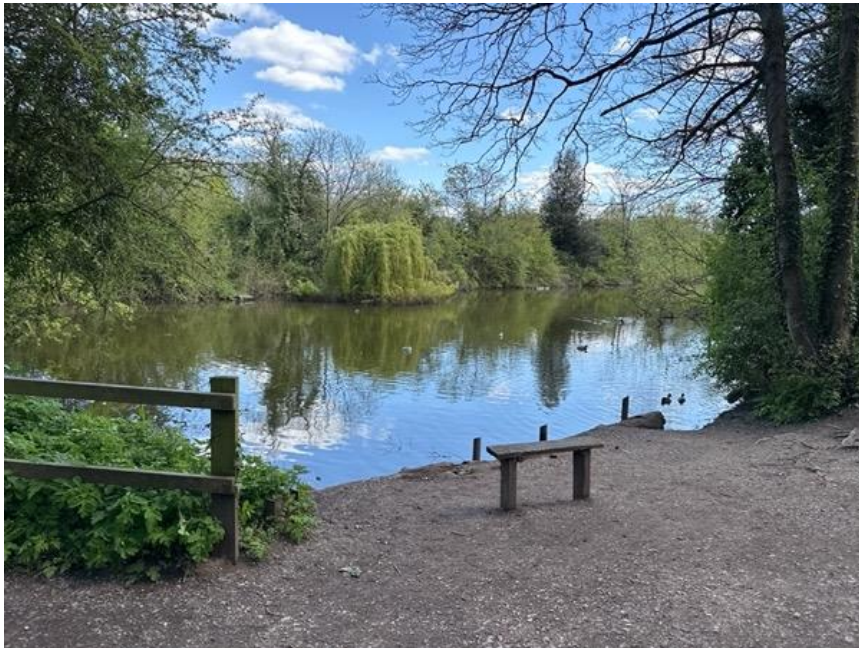
There are access points which are clearly marked, Photographic Plate 1. The lake has natural edge protection along a wide length of the lake, Photographic Plates 1 and 2.

Photograph 1 : Clearly Defined Access to Water

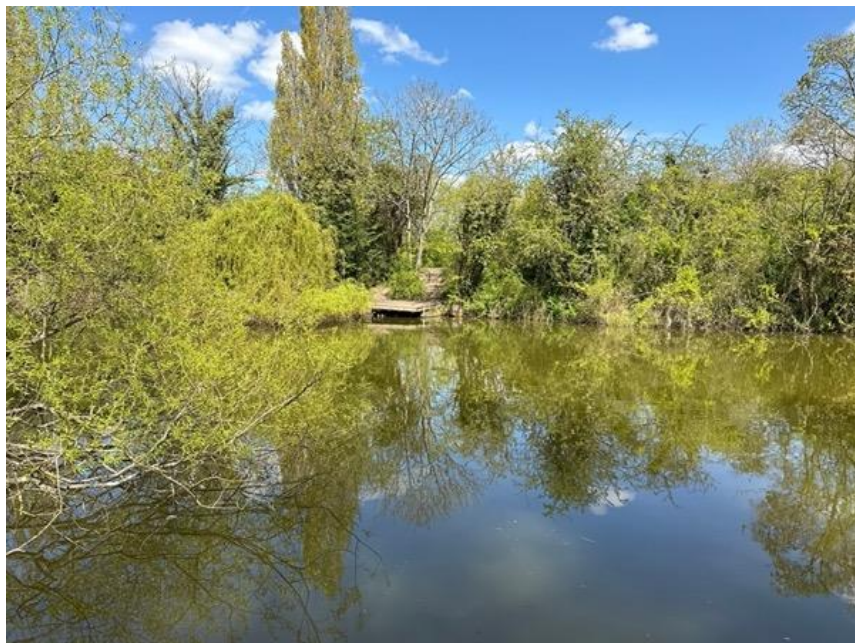
Photograph 2 : Natural Edge Protection and Fishing Peg

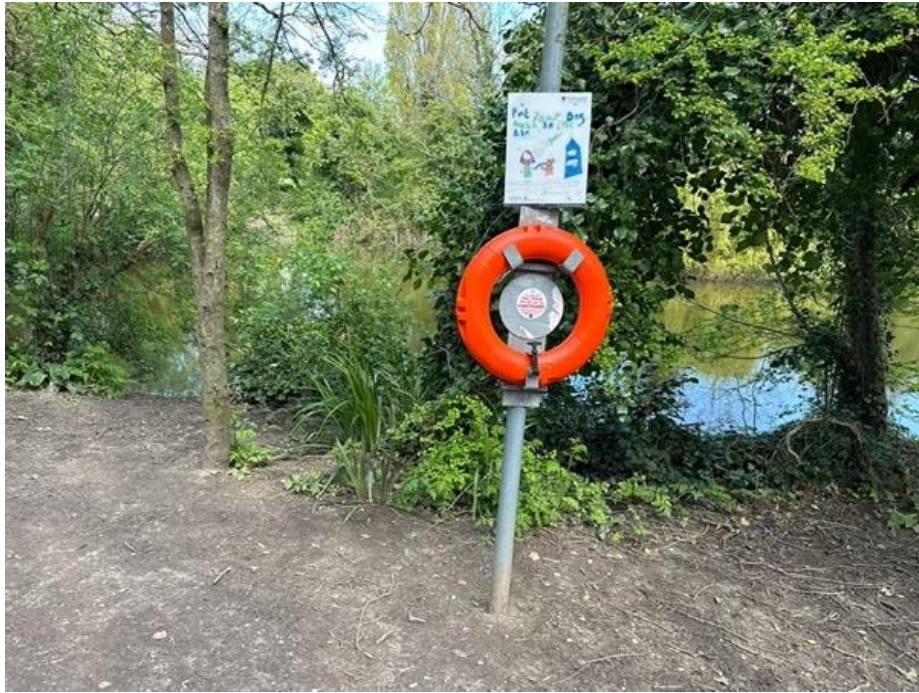
Life rings present at certain points, but often missing or in pond through vandalism, Photographic Plate 3.

Photograph 3 : Life Ring

Create working group and consider removing PRE due to location, vandalism and no history of water activity. Continually monitor through the year with quarterly audits.

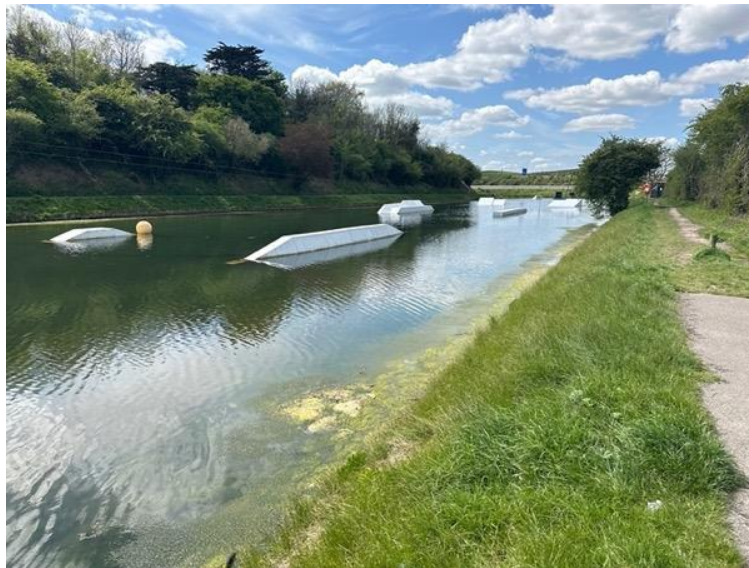
The path around the water body is away from the water margin and in general stable, Photographic Plates 1 and 2.

Photograph 1 : Wakeboard Park

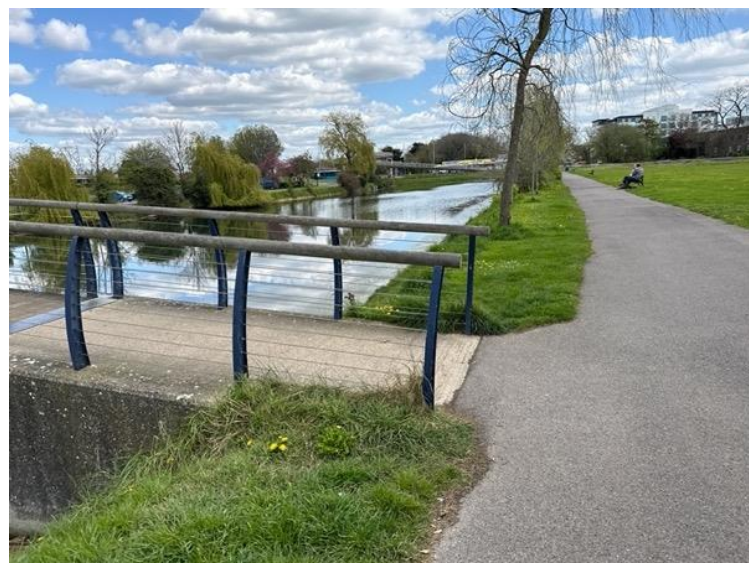
Photograph 2 : Bridge Across Waterbody

Place a similar sign to the chalk pits on either side of the foot bridge and at seating positions, Photographic Plate 2.

Place one PRE at the bridge and one at the seating positions which covers access points and congregation point.

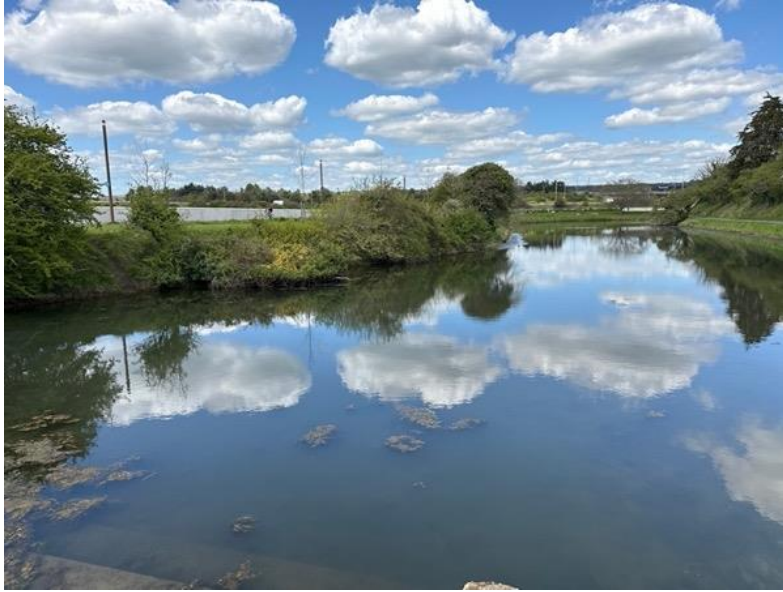
There is grass bank gradient down to narrow block ledge before water. There is natural edge protection on south side, Photographic Plate 3. There is limited risk that you could fall into the water. Any immersion would be through choice.

Photograph 2 : Lake Banks

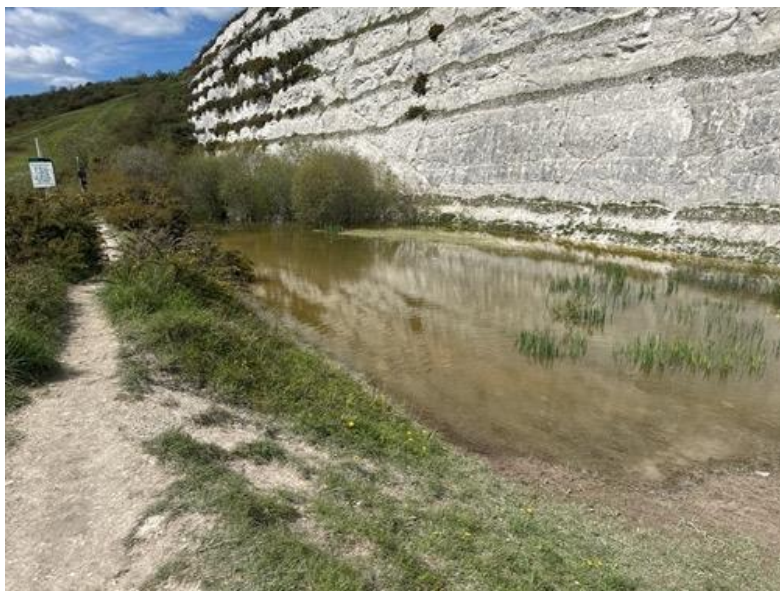
The pond is shallow with no hidden drops into the water. The water margin is clear, Photographic Plate 1.

Photograph 1: Clear water edge

No changes. Continually monitor for changes to the environment with at least quarterly visits.

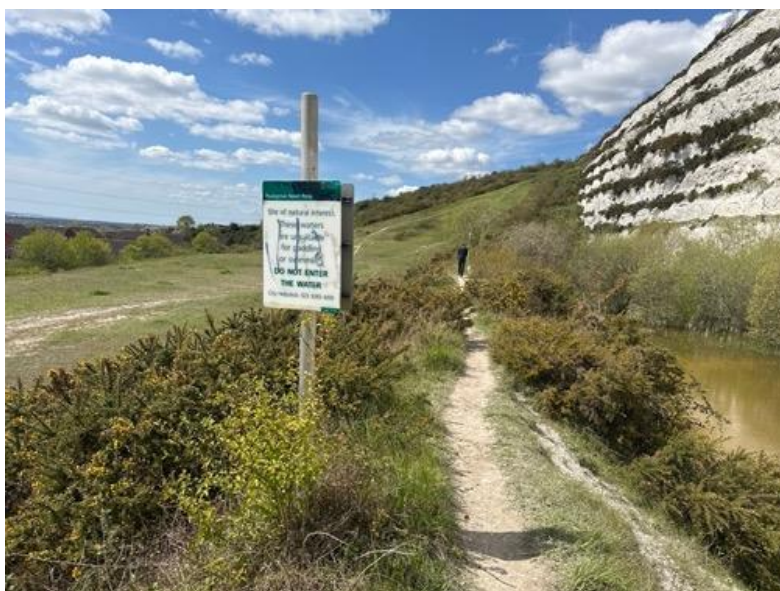
PCC info sign advising site of natural interest and not to go in the water. 'These waters are not suitable for paddling or swimming. Do not enter the water', Photographic Plate 2.

Photograph 2: Water Safety Sign

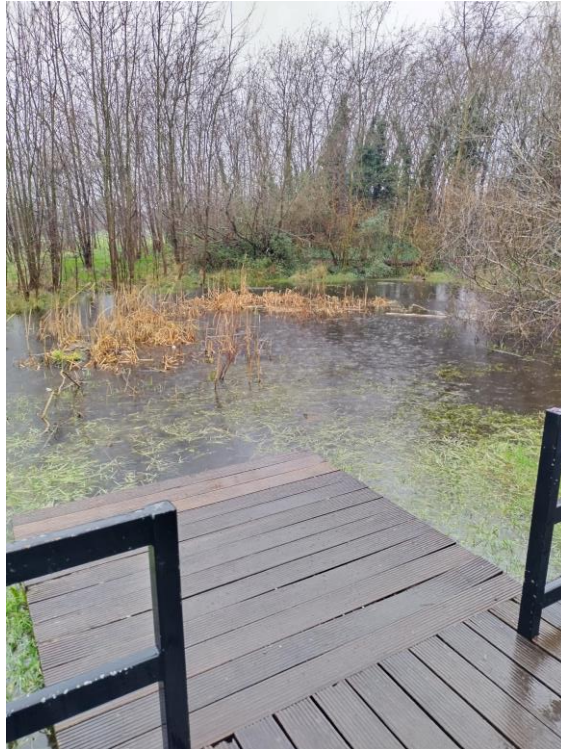
The pond is shallow with a clear decked viewing platform on the east side. The entrance to the platform has railings either side to prevent wheelchairs or buggies falling off the edge. The rest of the pond boundary is surrounded by trees and vegetation protecting from accidental entry to the pond

Photograph 1 - Tamworth Pond

No changes required. Continue to monitor site for significant changes via quarterly visits.

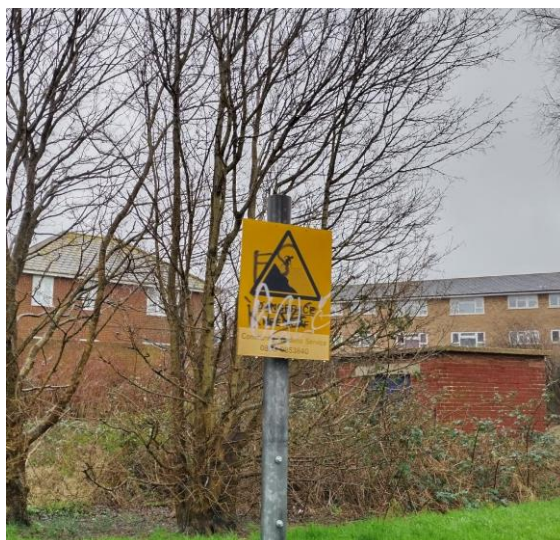
Yellow warning sign advising of danger of ice.

Photograph 2 - Danger of Ice sign

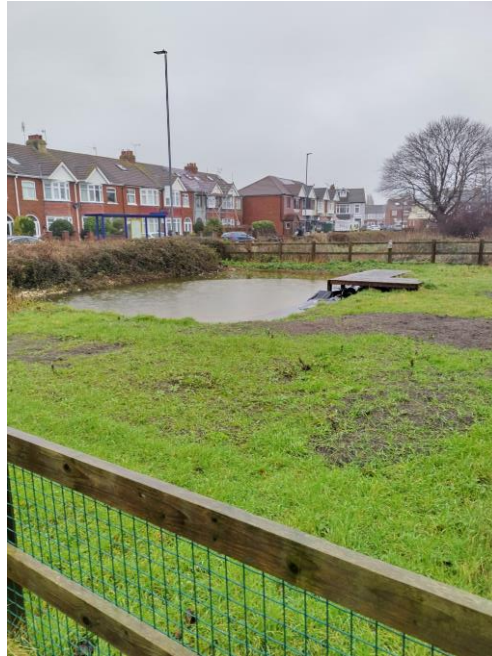
The pond is situated in a fenced off area with gated access which prevents accidental egress to the pond by users of the adjacent open park space. Within the fenced area the pond has a decked platform to allow safe access to the pond without the need to negotiate the banked edge.

Photograph 1 - Baffins Dipping Pond

No changes required. Continue to monitor site for significant changes via quarterly visits
