# **Civic Offices**

Annual Running Costs and Condition Survey

Briefing Session July 2022\*

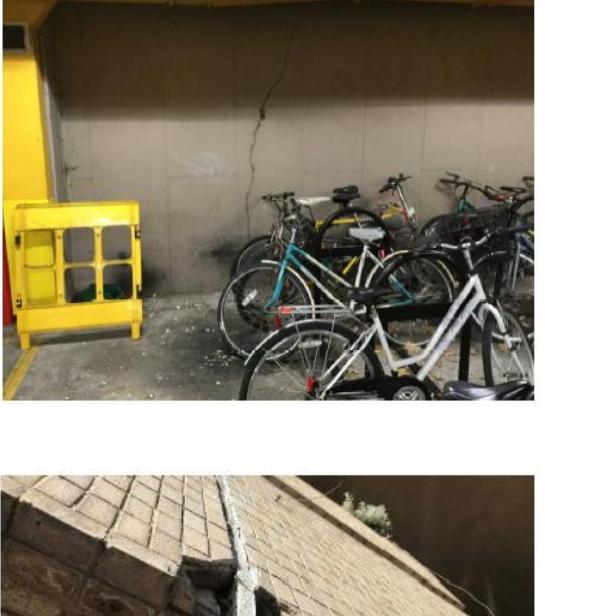
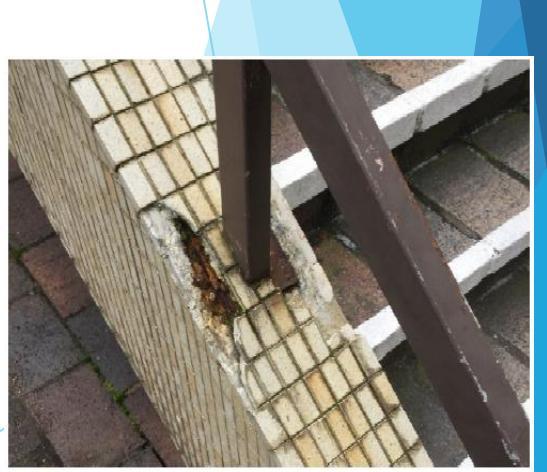
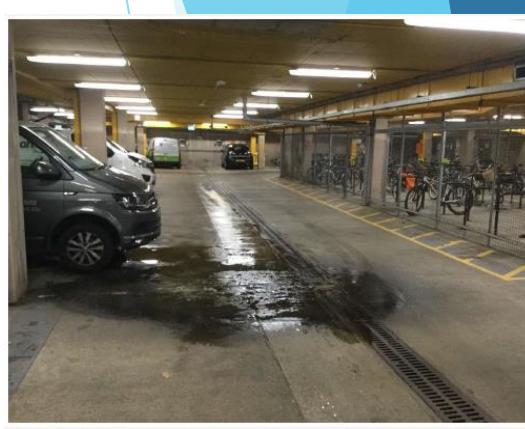
### **Condition Survey** - Structure

- Generally fair condition
- Historic cracking to concrete elements
- Water ingress to basement and core 6
  - Currently superficial
- Corrosion of handrail fixings
- Various areas of damage to tiled surface
  - Currently superficial
- If structure kept watertight deemed to have ongoing serviceable life\*

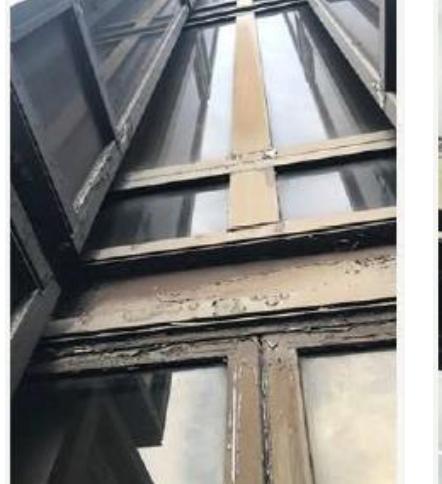
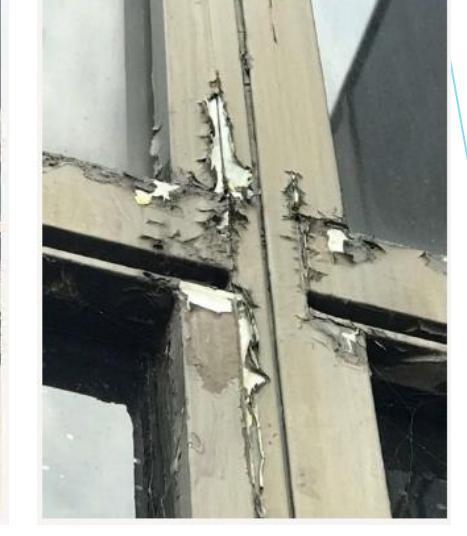
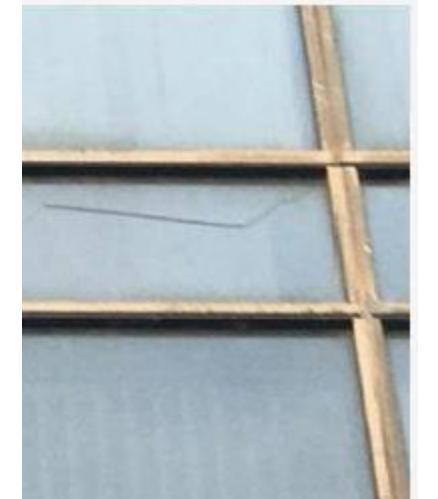
# **Condition Survey** - Curtain Walling

- Failing external coating will lead to corrosion of frame
- Seals deteriorating and hardening will eventually cause leaks
- Single glazed with secondary glazing
- Mullions misaligned building movement
- Some cracked glazing
- Lack of fire stopping between floors
- Excessive solar gain
- Poor thermal performance
- Overall external envelope is in poor condition and in need of replacement
